Alfa Romeo 147 156 166 GT Multi-Function Steering Wheel Audio Radio Control Push Touch Rubber Buttons Controls Instructions Install Guide

by [x8rltd](#) on August 16, 2016

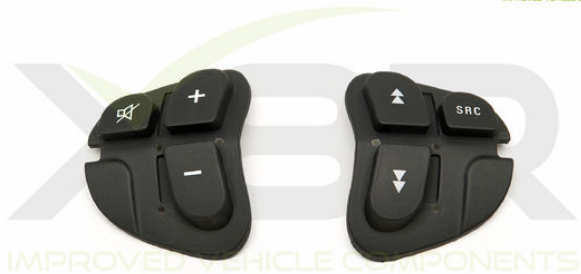
The steering wheel audio control buttons are worn, rubbed off, edges deteriorated, light leaking / bleeding where painted or rubber has worn off.

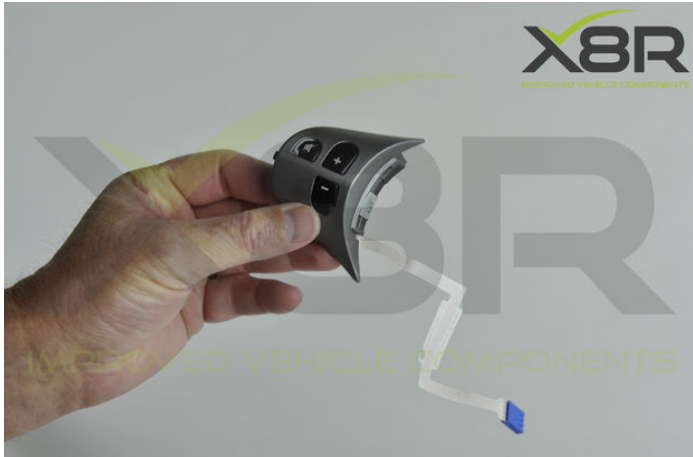
Step 1: Remove the button units from the steering wheel

On the reverse of the steering wheel remove the 3x Allen head bolts holding the air bag. These will loosen but will not come out.

Lift out the airbag. Some opt to un-clip the electrical connector others leave connected and balance airbag out of the way. Please follow manufacturers guidance for your vehicle model.

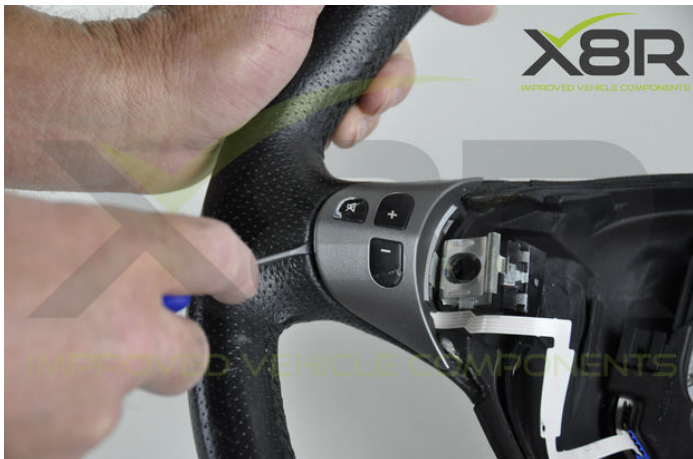
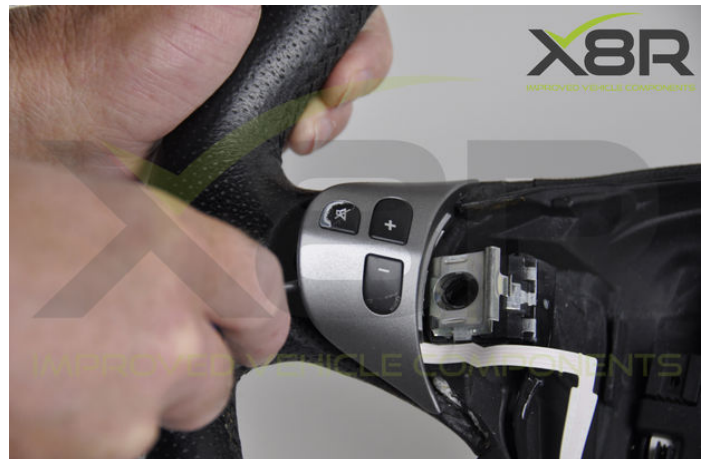
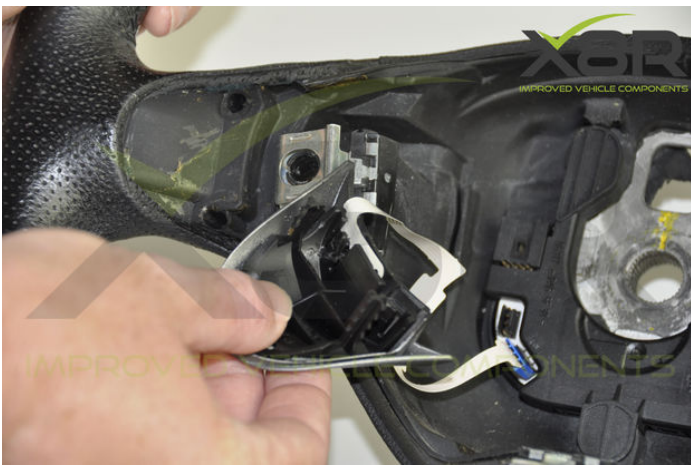
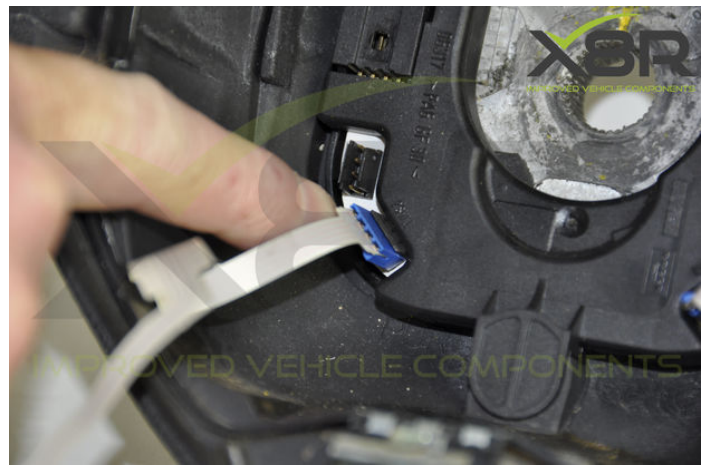
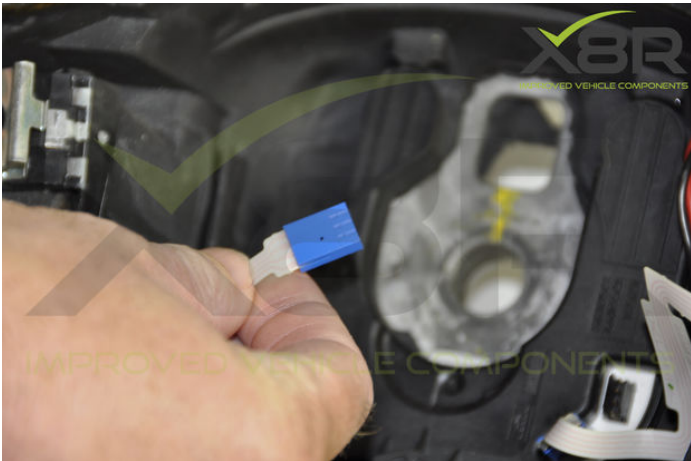
Step 2: Remove the button unit

Remove the silver colour button unit.

Gently lever out of position.

Once button unit is freed disconnect the electrical connector on the ribbon from the steering wheel.

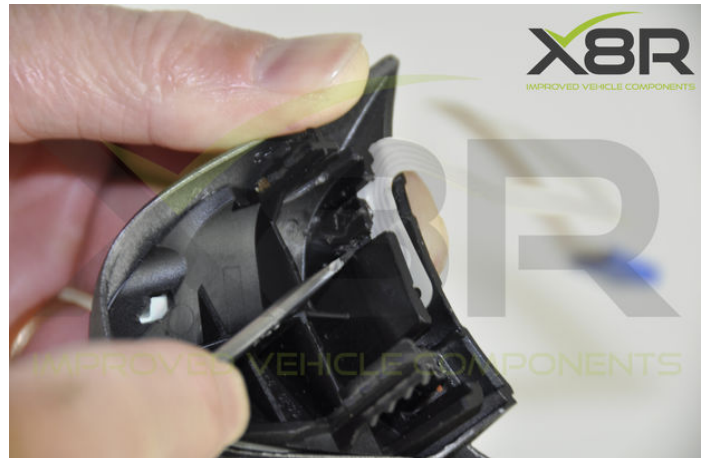
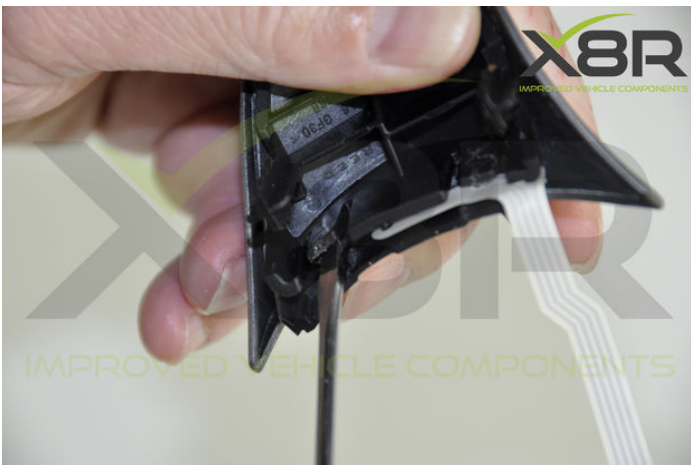
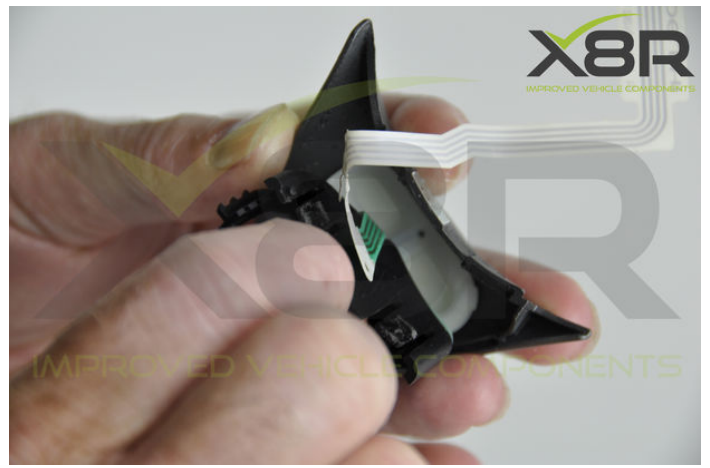
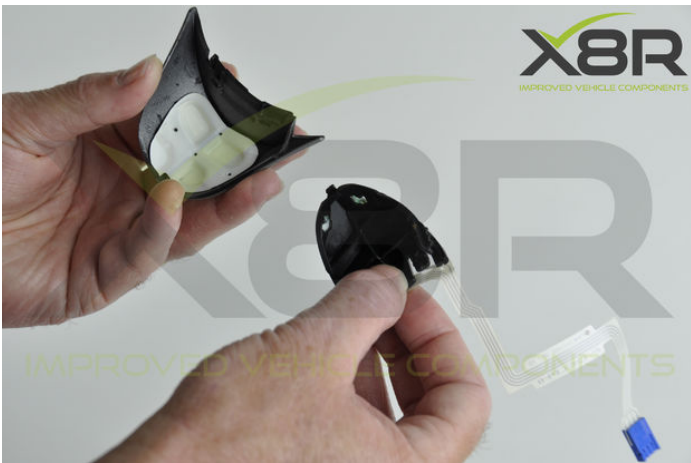
Step 3: Split apart the button unit

Lever back the black tabs as shown with a small flat bladed screwdriver.

One of the tabs has the ribbon running behind it take care not to damage the ribbon when levering.

You will hear a click once released, you can then separate the black plastic from the silver housing.

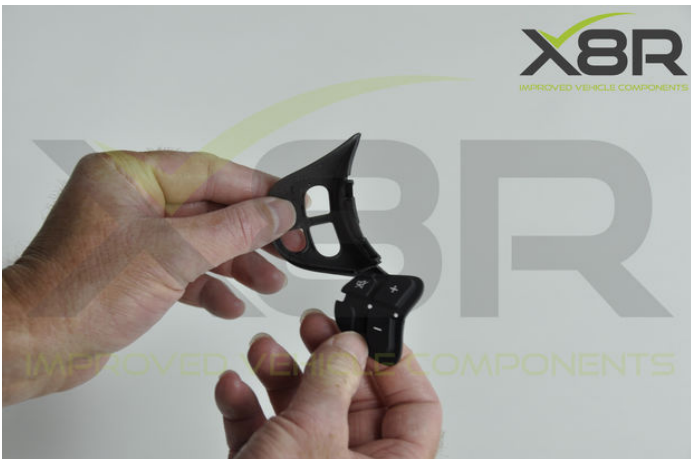
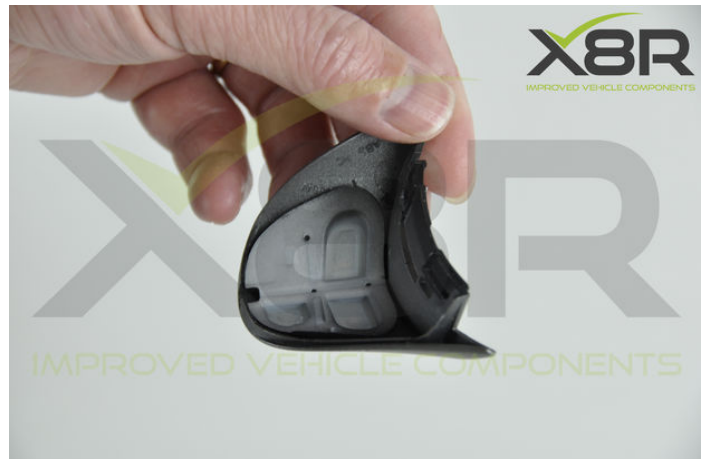
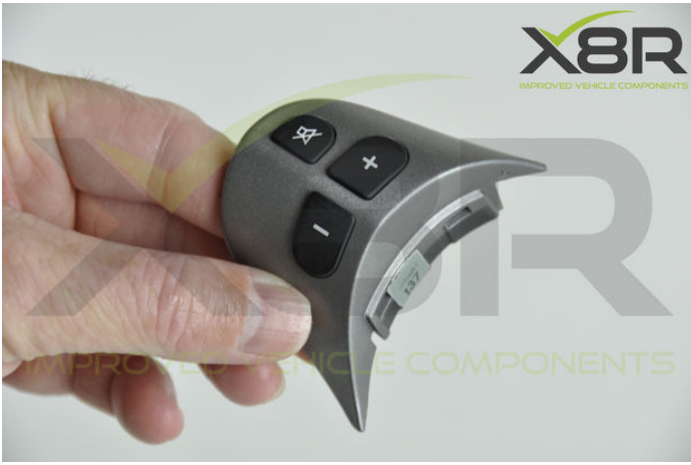
Step 4: Replace the rubber buttons

Lift the old buttons out of the silver housing and replace with our new buttons.

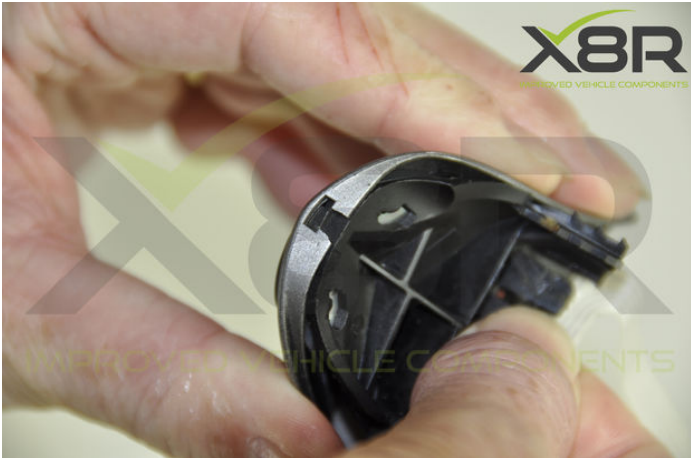
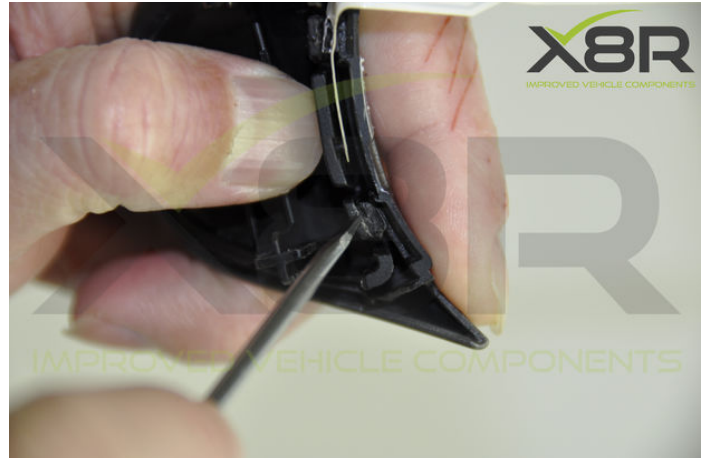
Step 5: Refit to housing

Slide the black plastic back in to the silver housing, at the opposite end to the black tabs, the black plastic slides in to a recess in the silver housing as shown.

The black tabs then need to be pushed down and forwards to retain to the silver housing, you will hear a click once secured. Again take care not to damage the ribbon that runs behind the tabs.

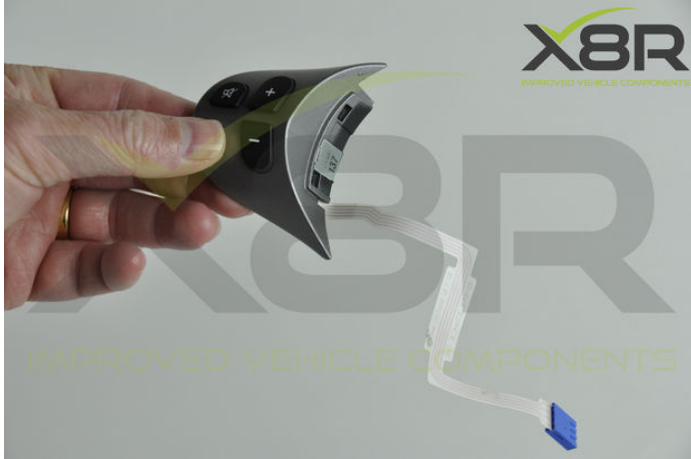
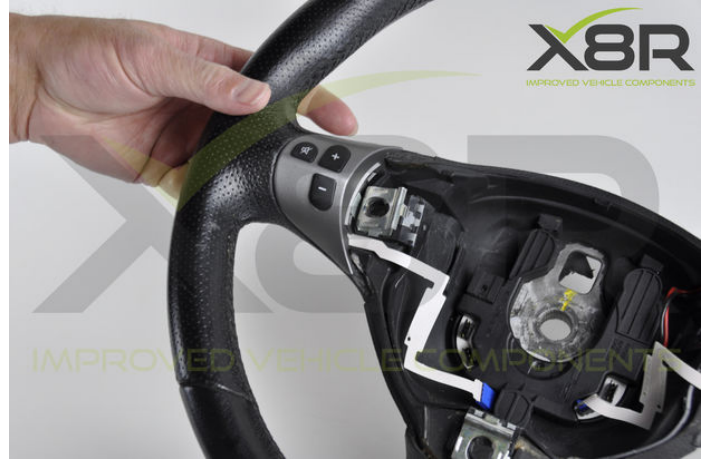
Step 6: Refit button unit to steering wheel

Push the button unit back on to steering wheel and reconnect the electrical connector.

Refit airbag and re-tighten Allen head bolts.

Test button function.
