BMW 6 Cylinder M52TU, M56, and M54 Dual / Twin / Double Vanos Rattle Repair Fix Process Instructions

Intro: BMW 6 Cylinder M52TU, M56, and M54 Dual / Twin / Double Vanos Rattle Repair Fix Process Instructions

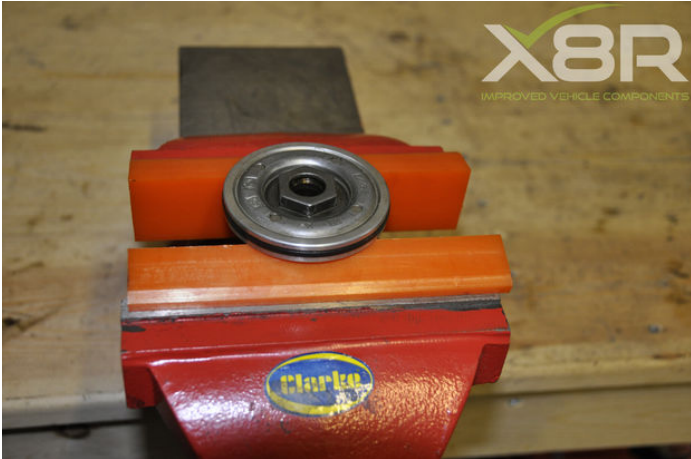
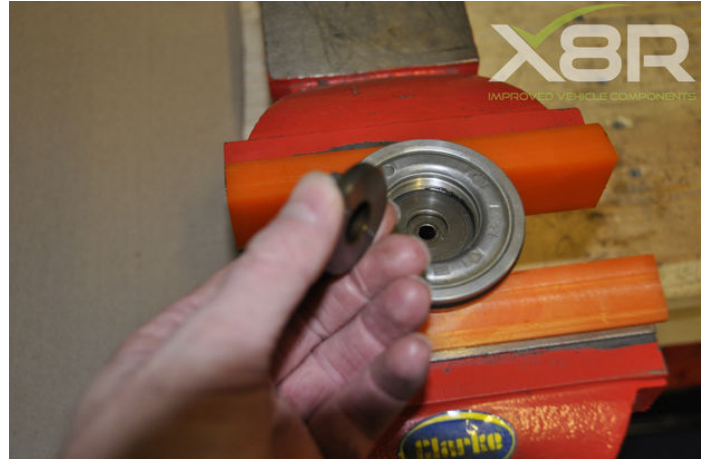
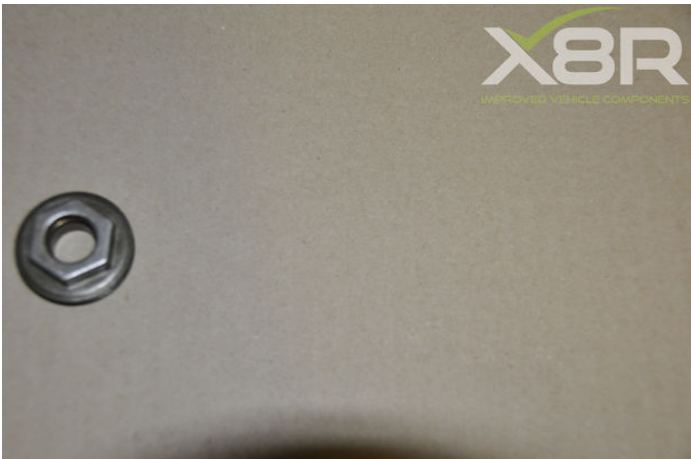
Step 2: Remove piston bolt

Remove piston and insert in to vise with soft jaws. Please note using vise without soft jaws WILL damage piston beyond repair. Only use 100% nylon soft jaws.

Loosen 24mm piston bolt with impact wrench, do not push down on wrench and use in lowest setting. Once bolt is removed loosen vice grip.

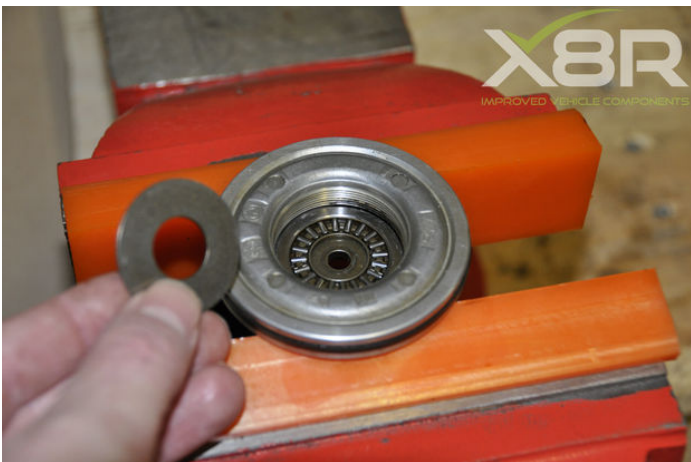
Step 3: Remove bearing top washer

Remove bearing top washer.

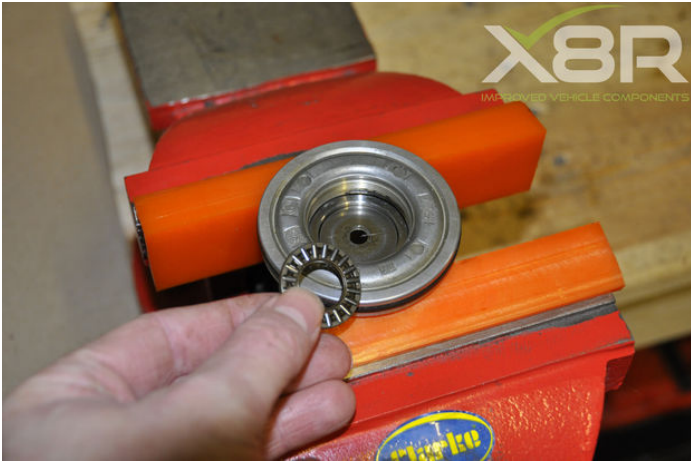
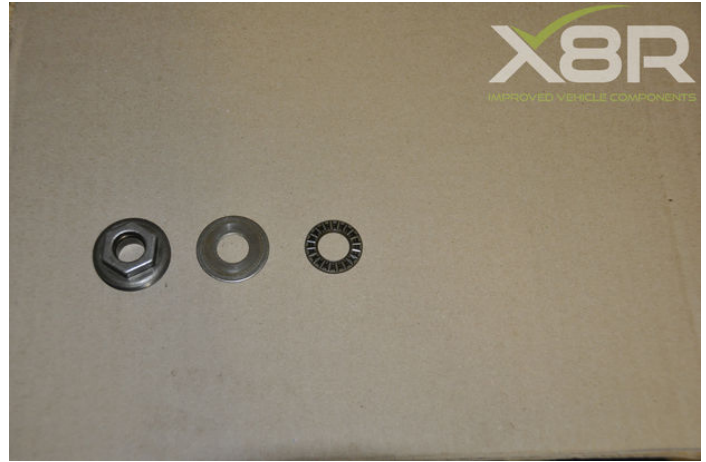
Step 4: Remove top bearing

Remove top bearing.

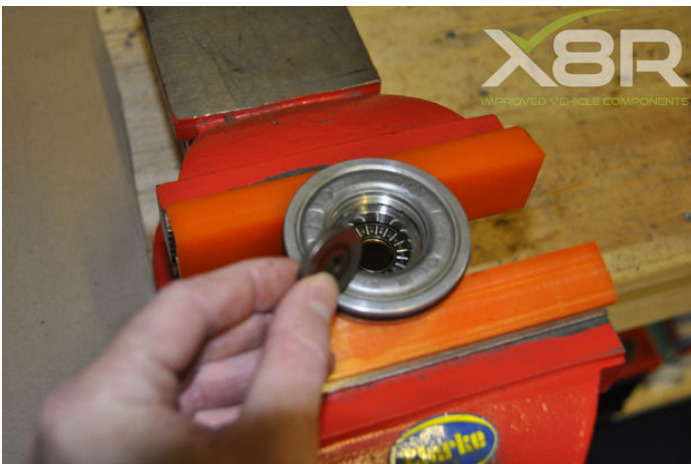
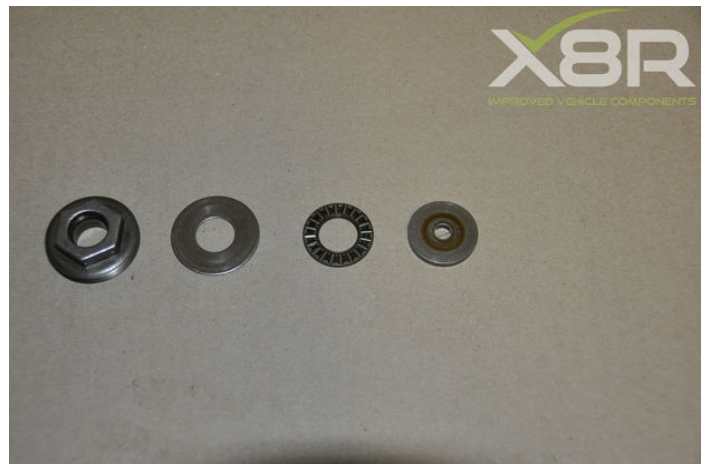
Step 5: Remove center washer

Remove center washer.

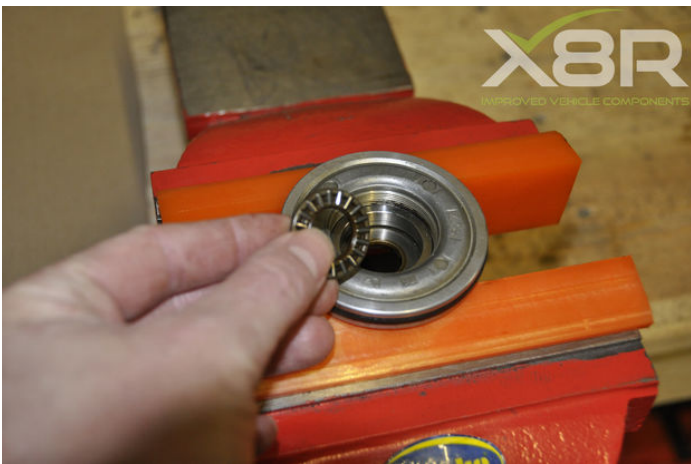
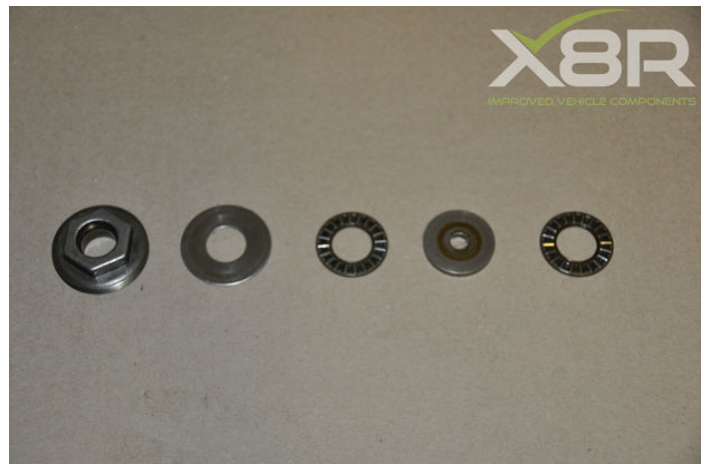
Step 6: Remove bottom bearing

Remove bottom bearing.

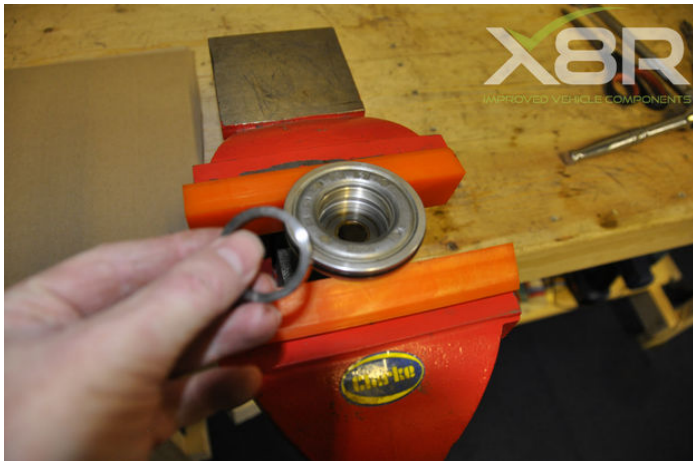
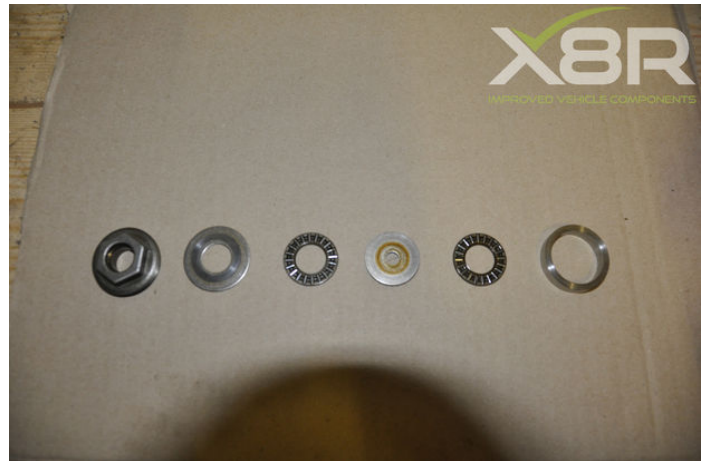
Step 7: Remove bearing outer ring

Remove bearing outer ring.

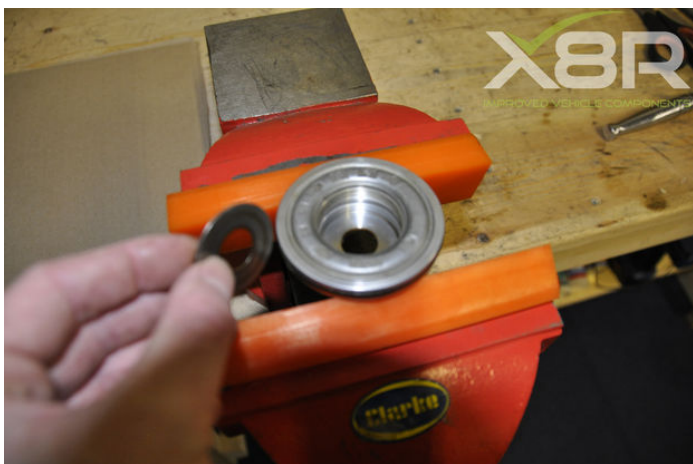
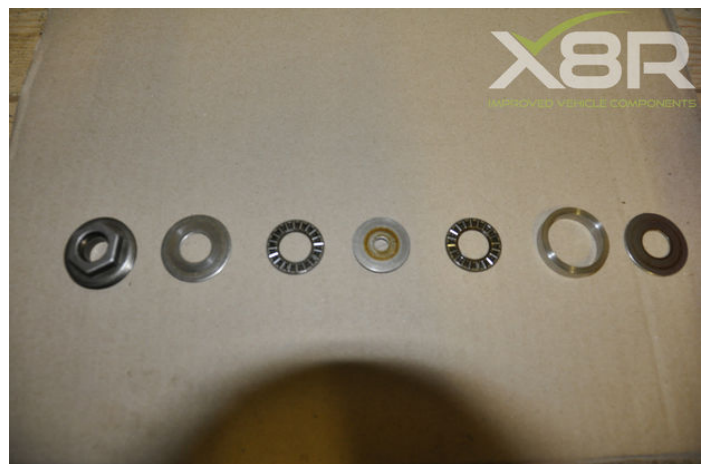
Step 8: Remove bottom washer

Remove bottom washer.

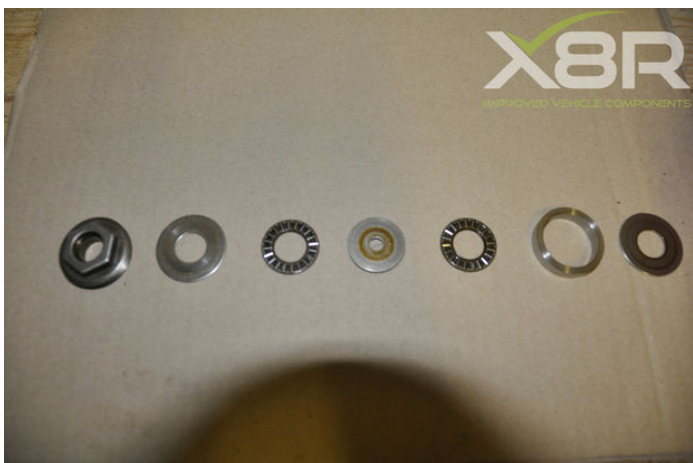
Step 9: Reinstall components with new outer ring

Clean all bearing components and interior of piston (brake cleaner)

Reinstall components in order left to right remembering to install our new outer ring.

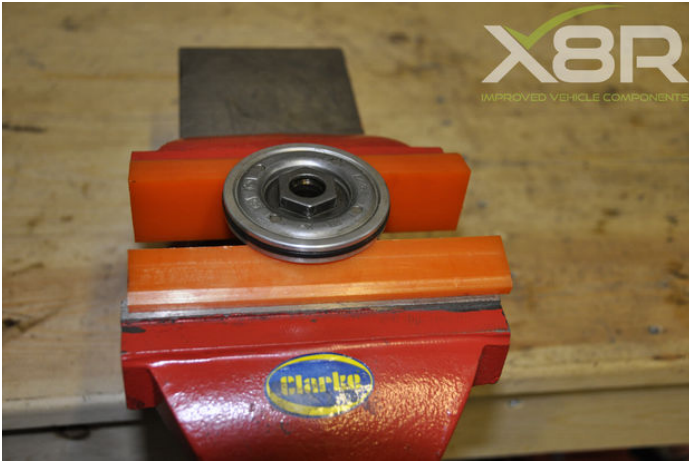
Step 10: Refit piston bolt

Clamp piston in vice with soft jaws. Refit piston bolt.

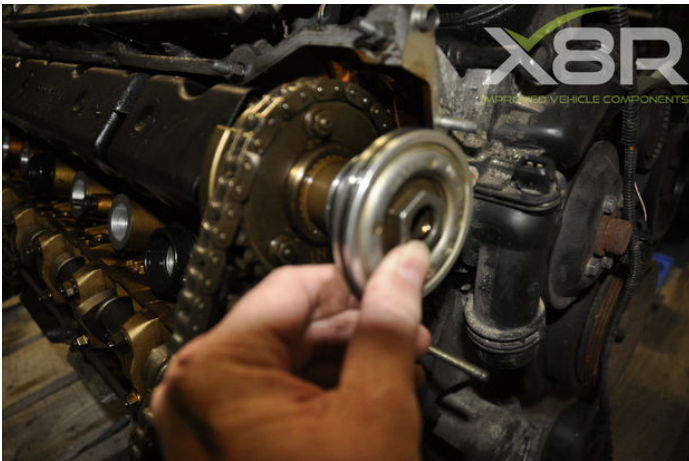
Step 11: Refit piston and test

Refit piston to intake splined shaft with piston mounting bolt (remember piston mounting bolt is left hand thread). Inspect piston axial play. Hold shaft and try to rock piston and note in/out movement.

If piston cannot be rotated or doesn't rotate easily axial fit is too tight and adjustment is needed. Disassemble piston again and locate bearing center washer. Place 400 grade sandpaper on flat surface and place washer flat on this. Push center washer up and down lightly for 10 seconds and repeat on other side. Reassemble piston and check axial movement, repeat process if necessary.

If piston rocks and there is in out movement axial play is still an issue and adjustment is needed. Disassemble piston again and locate bearing ring. Place 400 grade sandpaper on flat surface and place bearing ring flat on this. Push ring up and down lightly for 10 seconds and repeat on other side. Reassemble piston and check axial movement, repeat process if necessary.

Once fit is correct spray oil in to piston before refitting.
