Fiat Punto Upgrade Front Wiper Motor Linkage Repair Replacement Push Rod Rods Set 1999-2006 Instruction Install Guide

Intro: Fiat Punto Upgrade Front Wiper Motor Linkage Repair Replacement Push Rod Rods Set 1999-2006 Instruction Install Guide

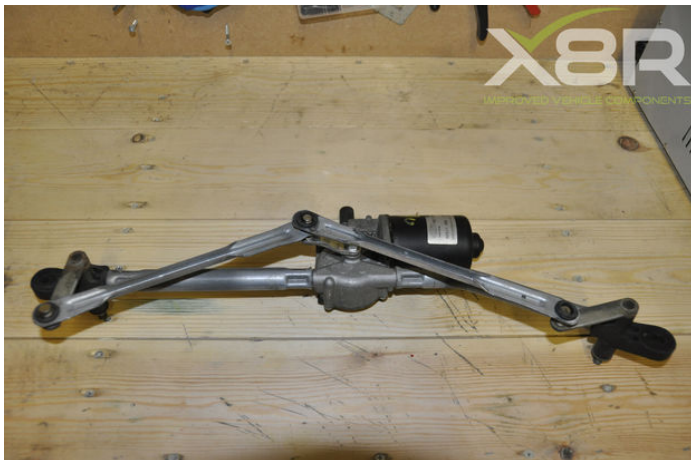
Step 1: Remove linkage from vehicle

Remove wiper arms. Remove plastic bolt covers and remove bolt and washer from both wiper arms. Wiggle wiper arms loose from splines, if difficult apply WD40 or penetrating oil and allow time to work. Take note of which arm fits to which spline for reinstall.

Remove scuttle panel. Remove 3x plastic clips retaining the scuttle and wiggle scuttle out of position.

Locate wiper mechanism and motor. Take note of positions of linkages, replicate positions when reinstalling the linkage mechanism.

Disconnect electrical connector to wiper motor, remove the 3x mounting bolts and remove from vehicle.

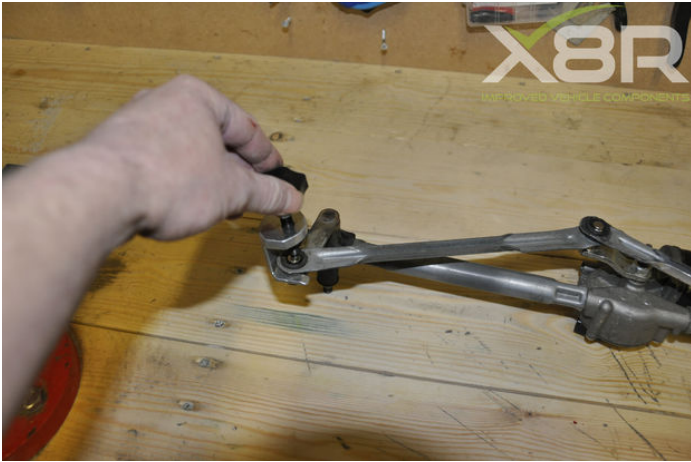
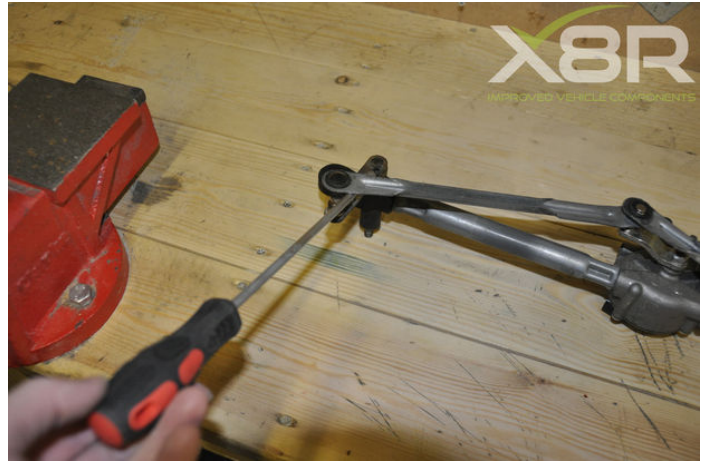
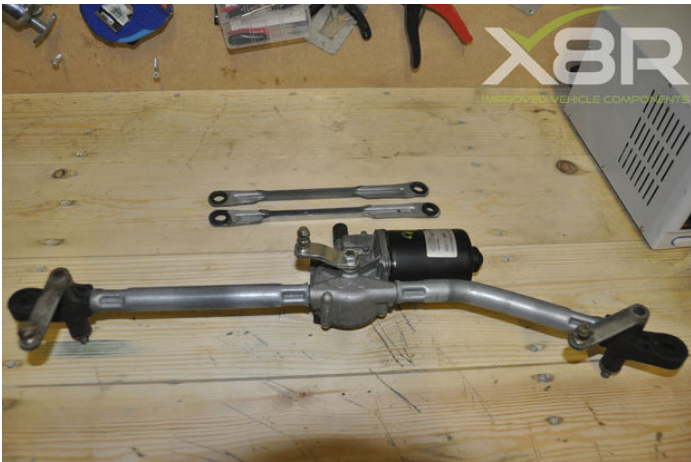
Step 2: Remove push rods

Remove push rods from ball joints. Often these are already hanging off or are very easy to remove as the bearing is very worn.

To remove you can use a puller as illustrated or can prise the rods off with a screwdriver as shown.

Once linkages are removed it is good practice to clean up the 3x ball joints, checking for any burrs that could damage the new bearings and smooth these out if evident. Grease up the ball joints and all moving parts of the linkage.

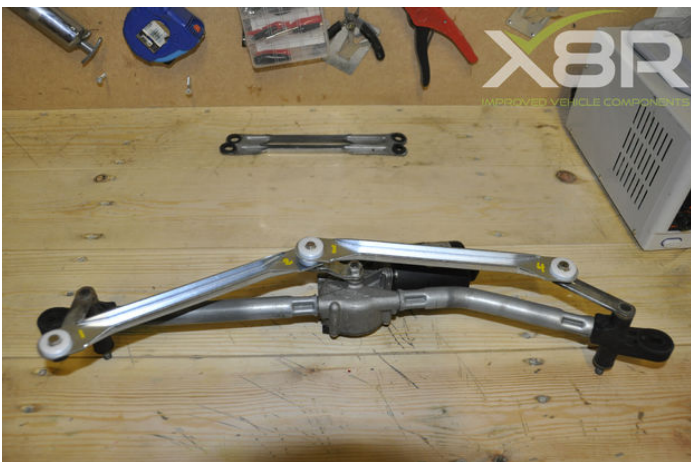
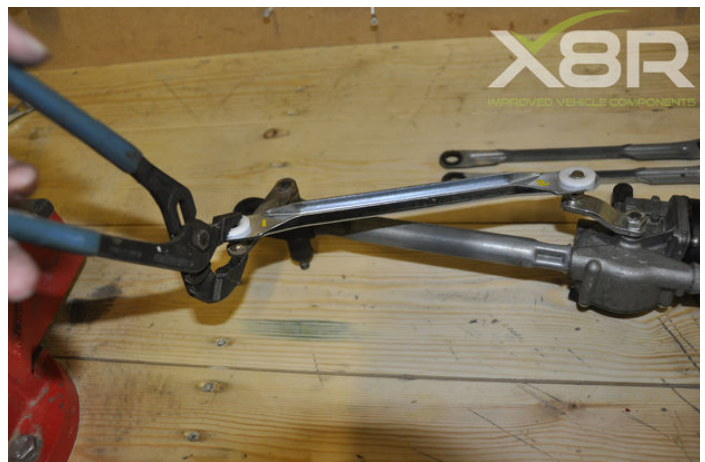
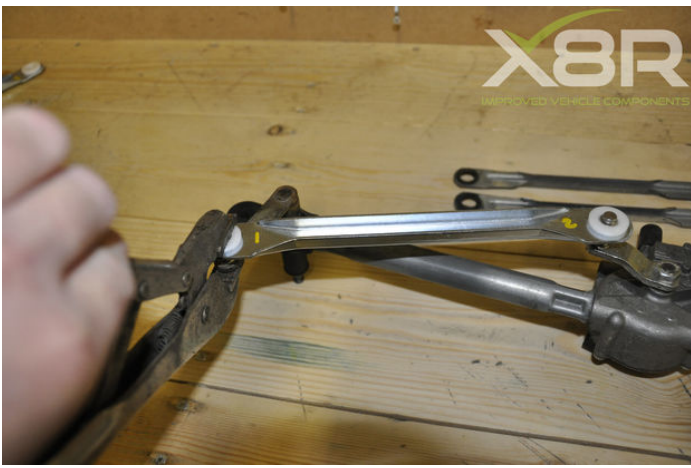
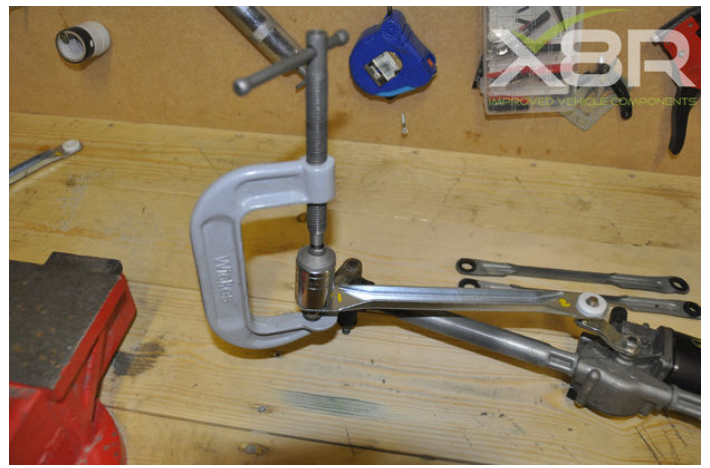
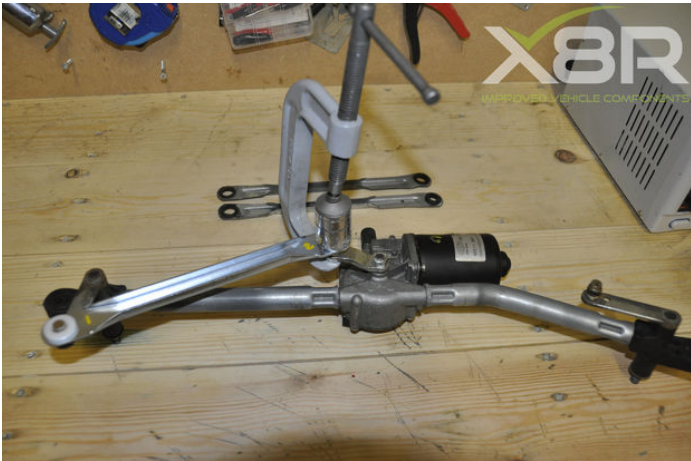
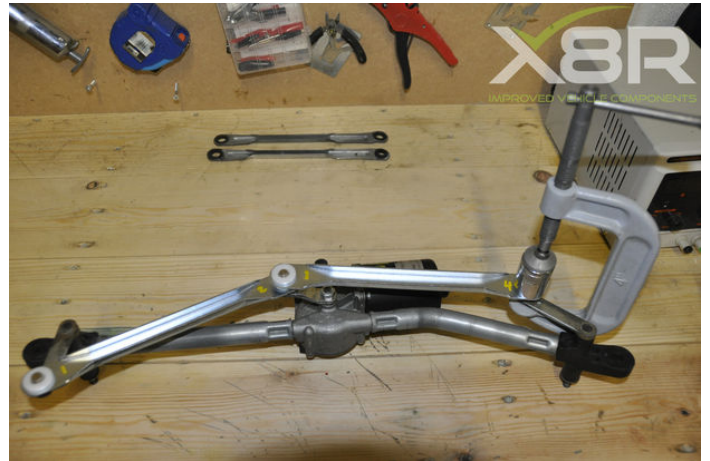
Step 3: Fit new push rods

The first image shows the order in which the push rods fit and their respective location.

To fit the rod to the respective ball joint you will need to locate the plastic bearing on top of the ball joint, the bearing can then be clamped in to place as illustrated and slid on to ball joint. This can be done with mole grips as illustrated, alternatively with a G Clamp and a socket slightly larger in diameter than the plastic bush. Our preferred method is the G Clamp.

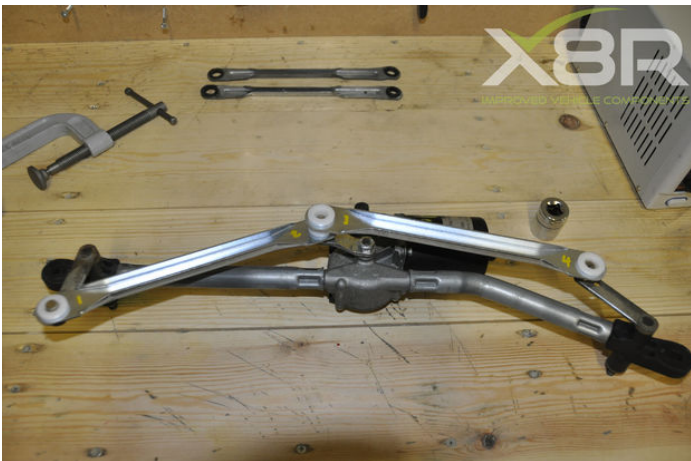
Step 4: Refit to vehicle

Ensure position of the rods is the same as when mechanism was removed from vehicle and refit to vehicle.
