## Fits Nissan Qashqai J10 JJ10 2007-2015 Front Windscreen Wiper Motor Linkage Link Rods Arms Rod Arm Repair Fix Kit Instructions Install Guide

by x8rltd

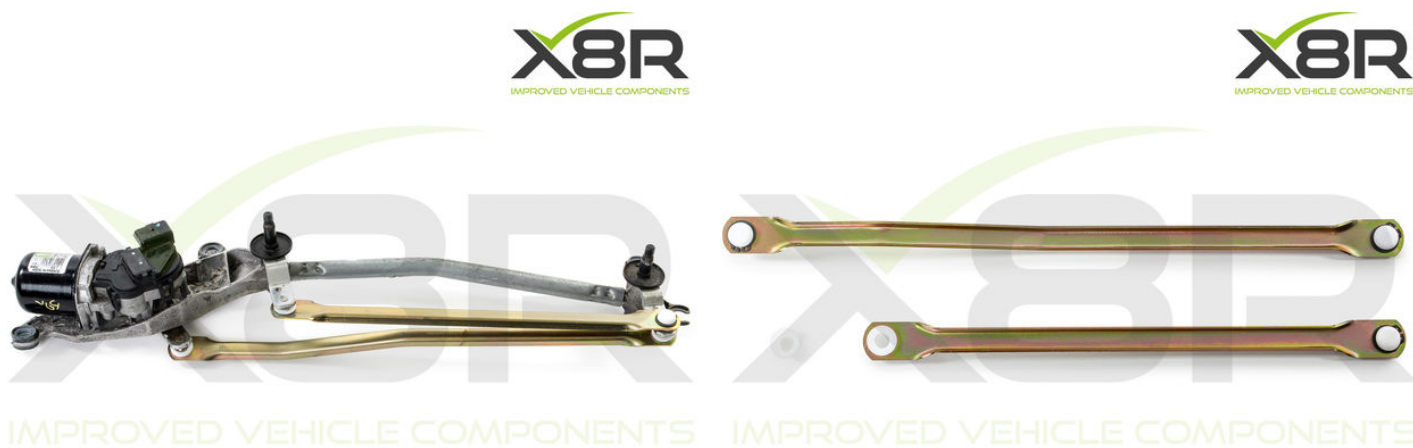
2x Rods fitted with high quality plastic bearings

1x Larger bearing bush

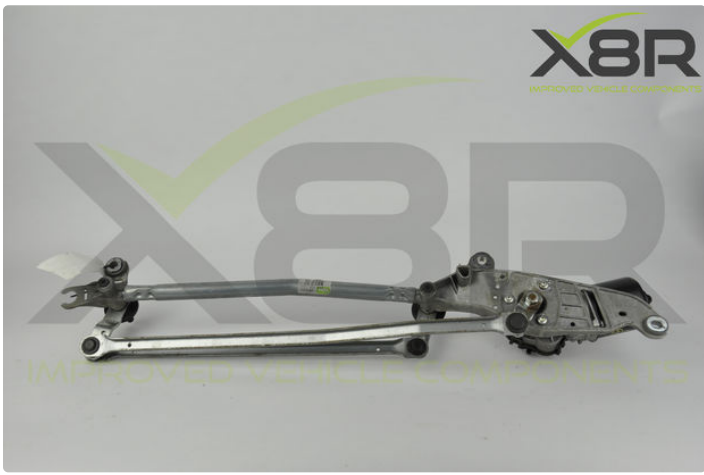
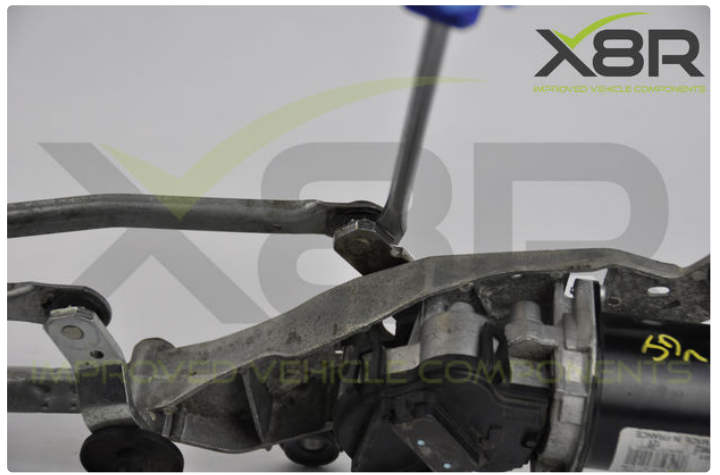
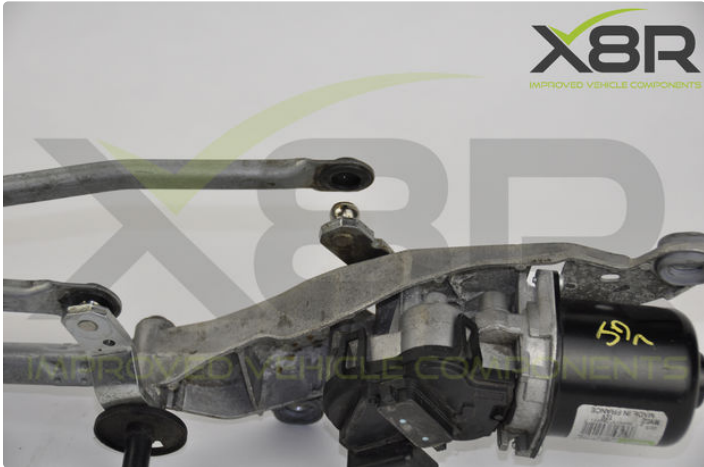
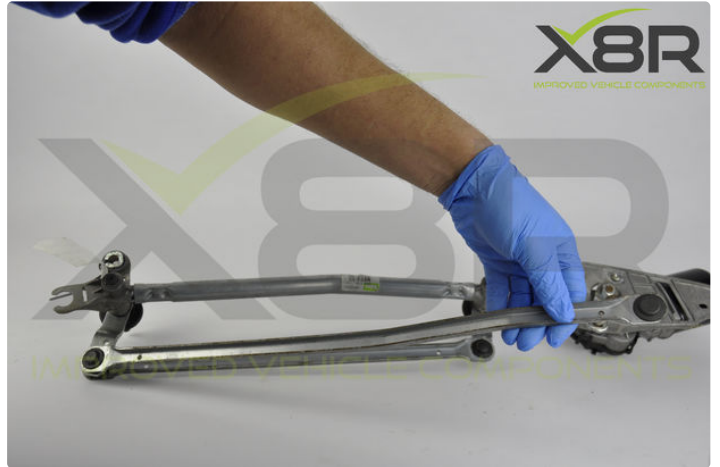
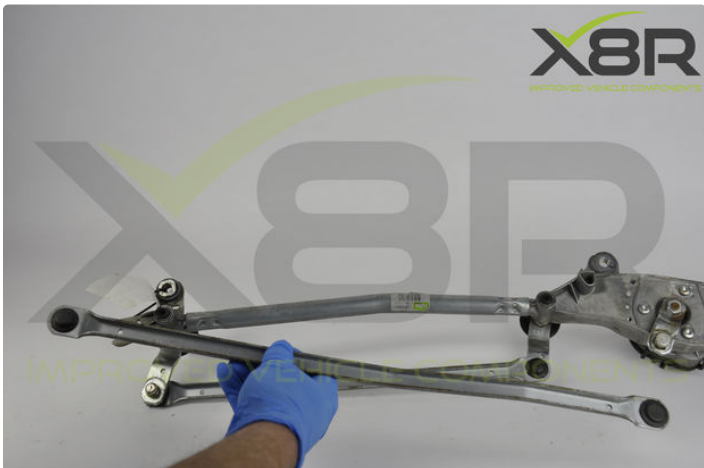
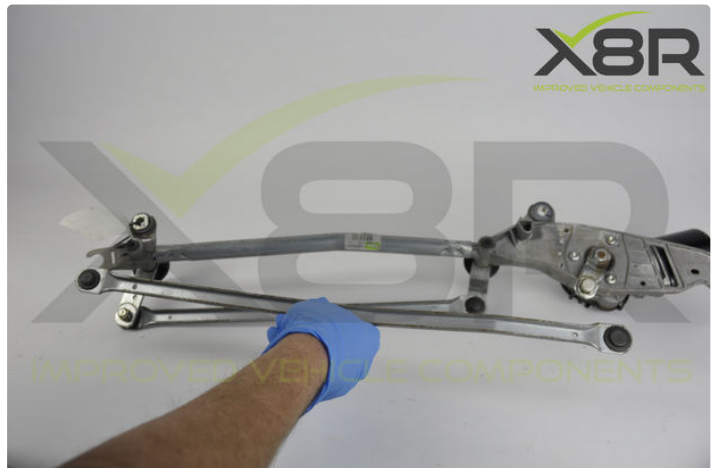
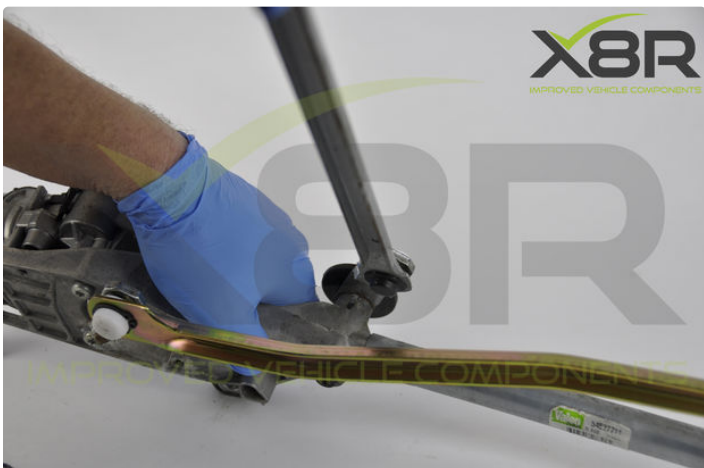
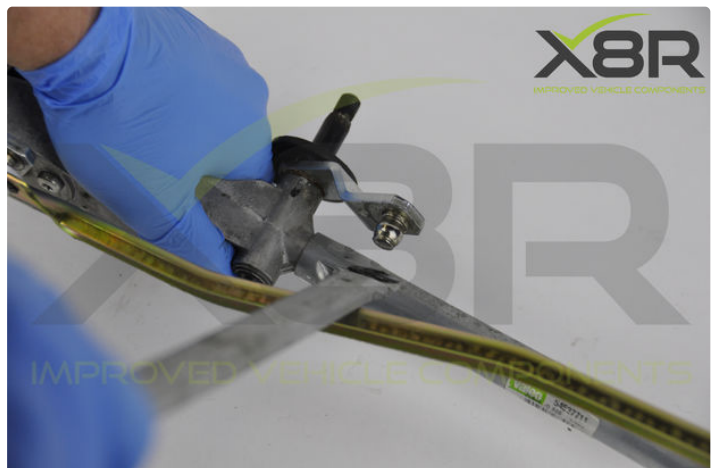
### **Step 1: Remove the Old Wiper Linkage Rods**

Remove the old wiper arms, one or two joints will likely be loose already, the others will pull off easily. If any resist lever off with spanner, pry tool or screwdriver.

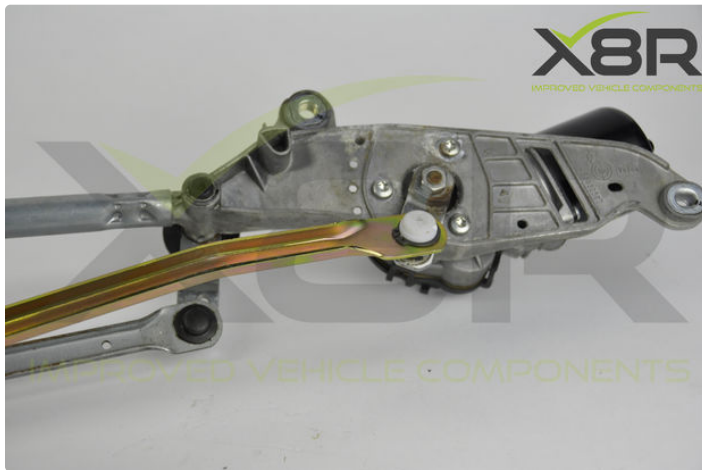
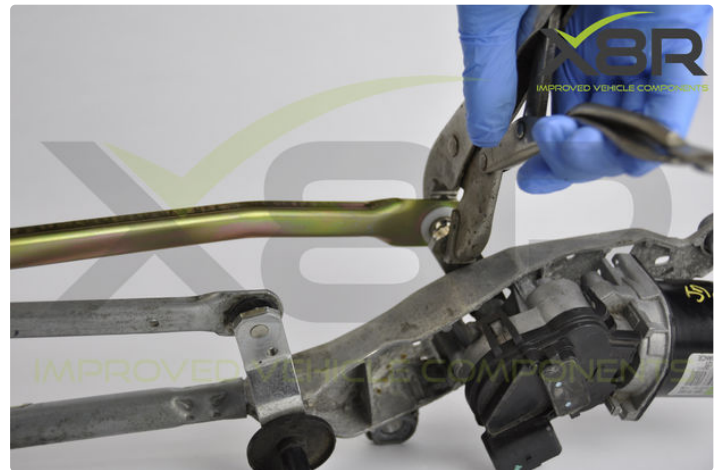
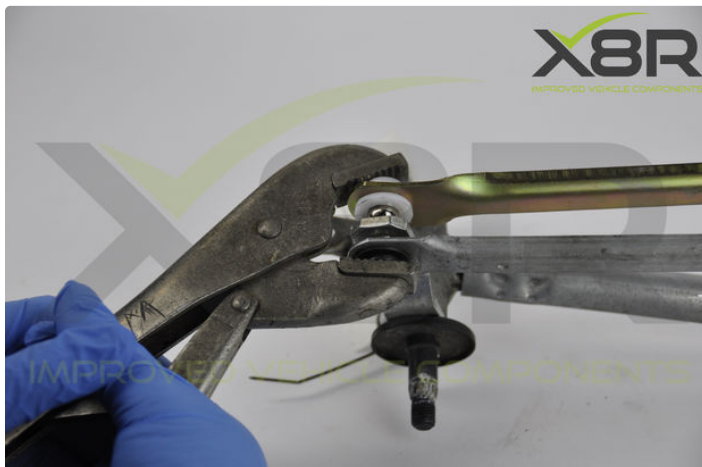
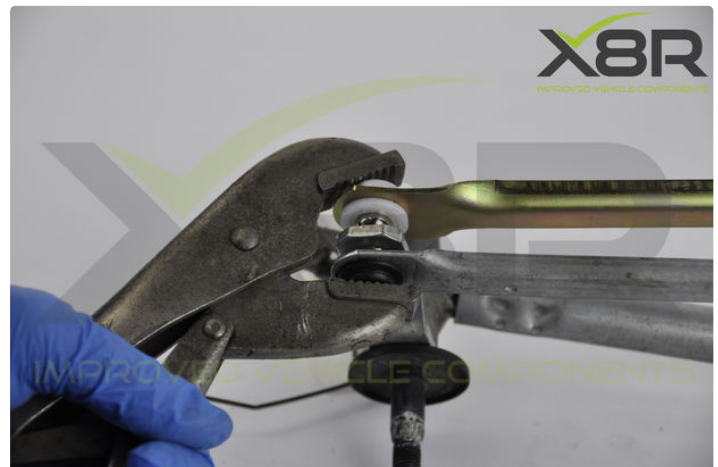
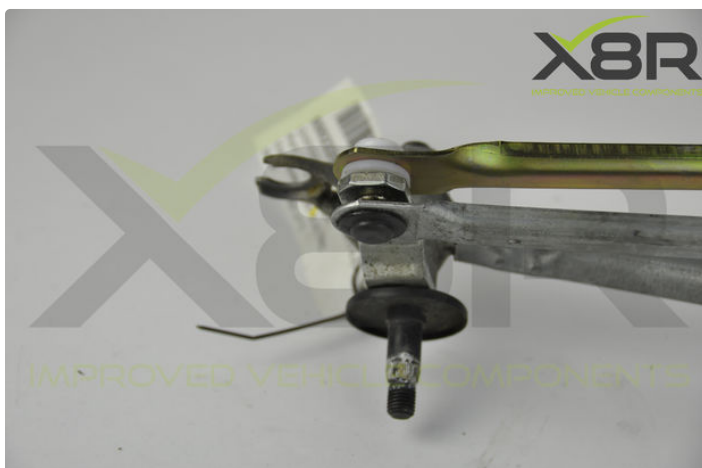
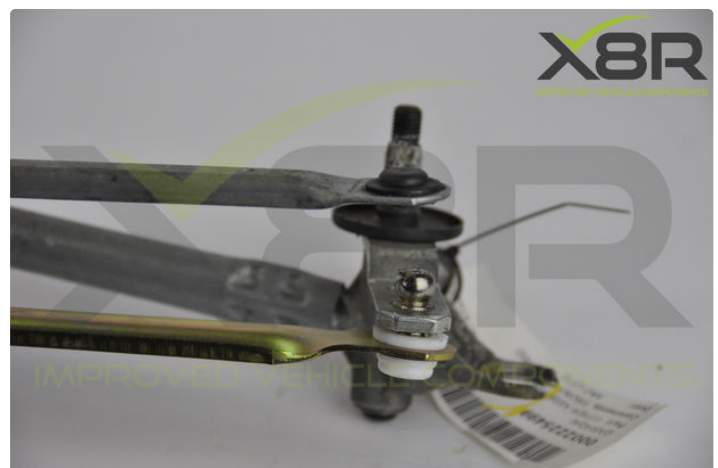
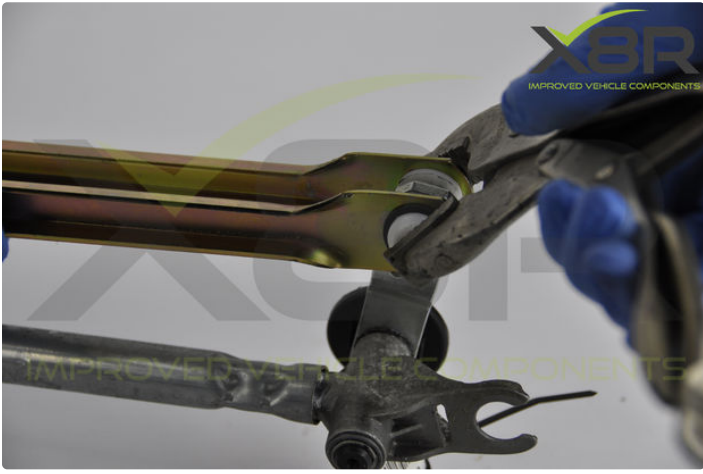
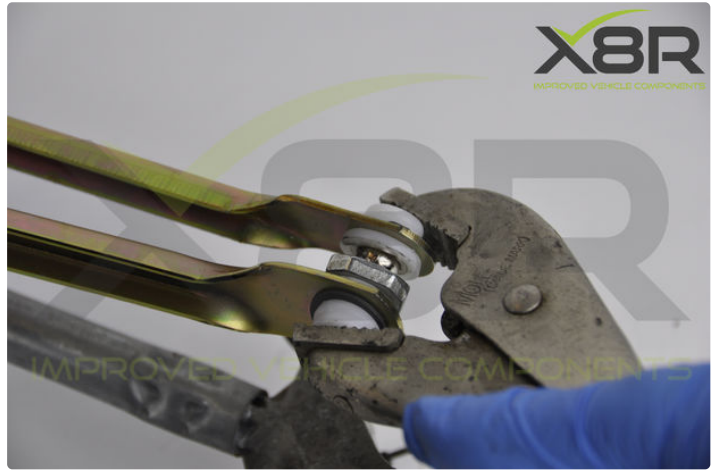
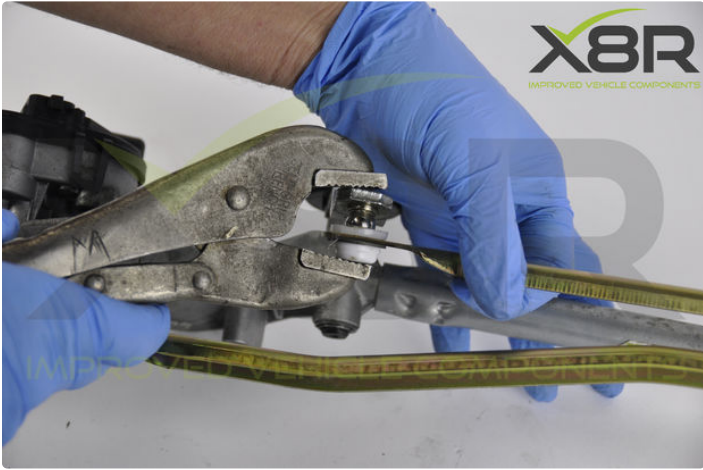
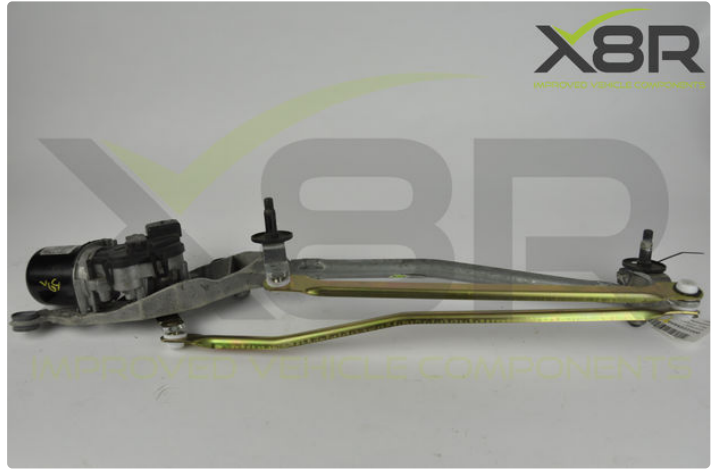
## Step 2: Fit Our Replacement Rods

Position our rods on to the ball joints and press on to the ball joints using a pair of grip pliers. The final image in this stage shows how the mechanism should look with our rods fitted correctly.
