Honda Civic CR-V HR-V Bonnet Hood Release Latch Lever Pull Cable Handle Repair Fix Kit Replacement Install Instruction Guide

by x8rltd

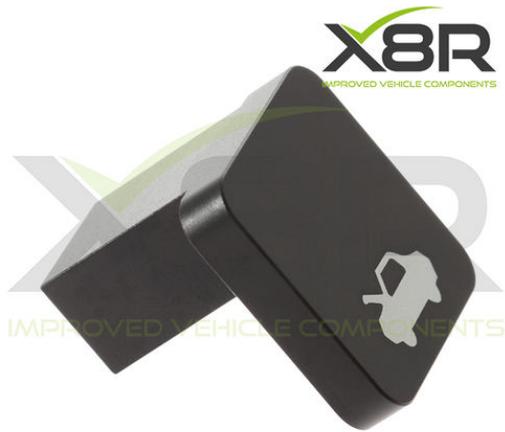
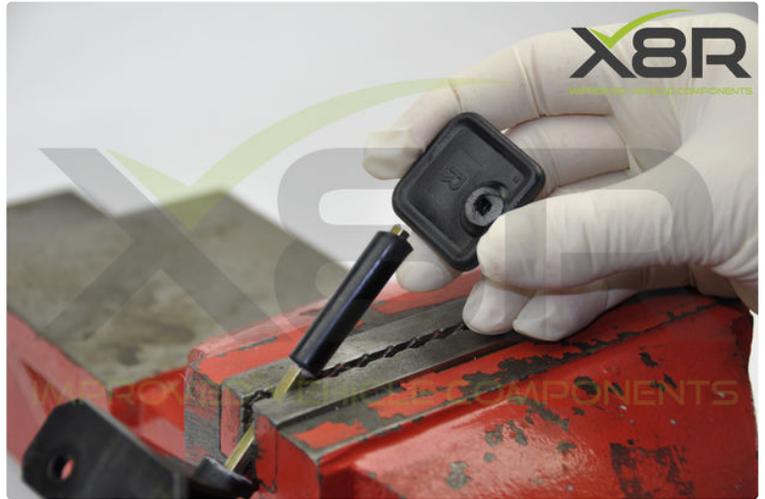
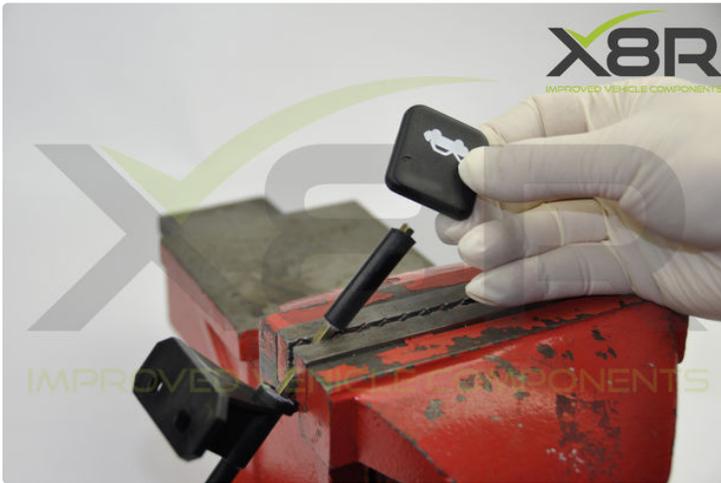
Our handle is CNC machined from billet aluminium, polished, black anodised then laser engraved with the car icon (not a sticker!) to match the look of the OEM handle but with the strength of a metal part.

Our part locks securely using two discreet set screws

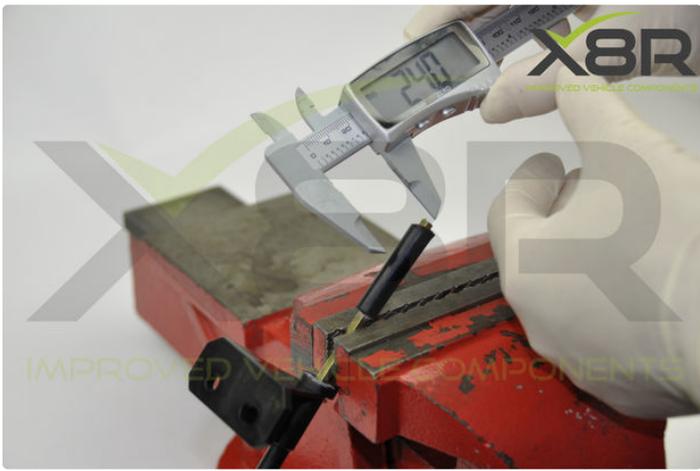
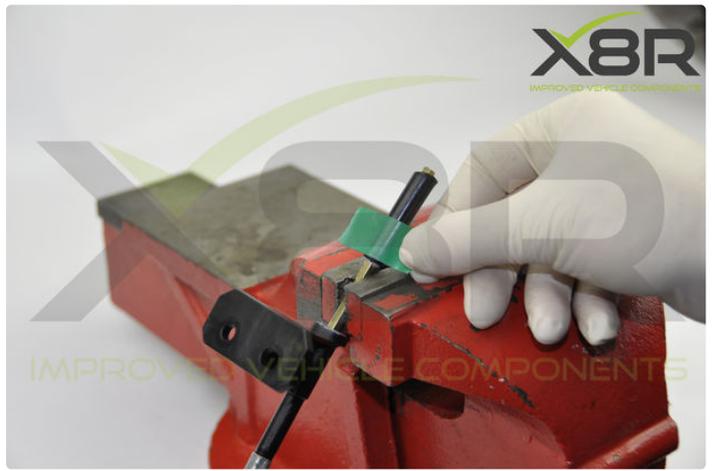
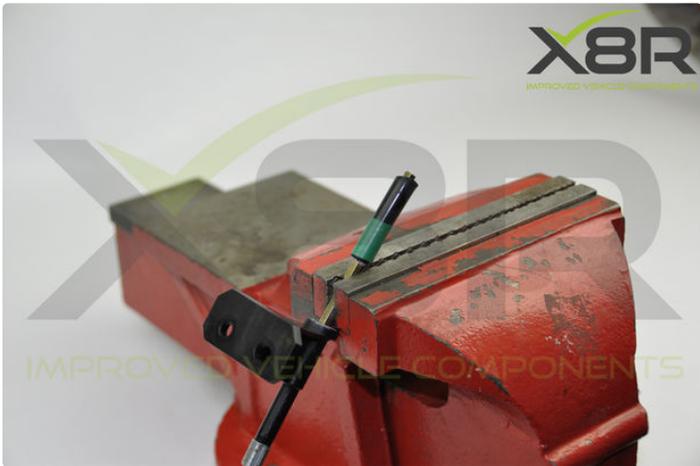
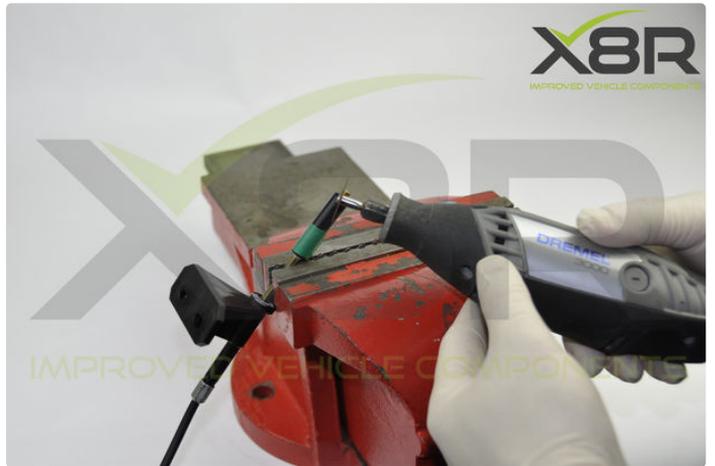
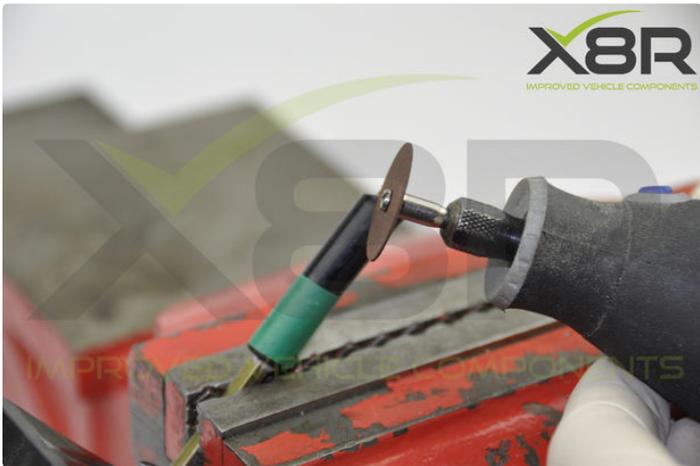
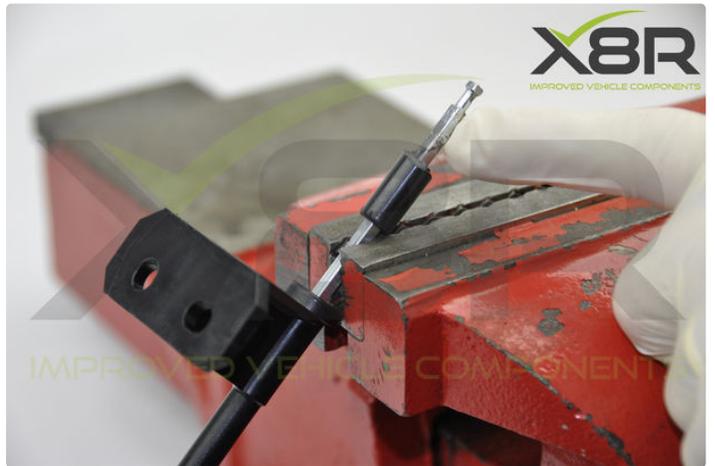
Step 1: Remove Old Handle Plastic

Measure and mark 24mm from the metal end of handle rod.

Using a Dremmel or suitable cutting tool cut away the plastic up to this point to expose the metal core. Cut away the plastic slowly and in increments so as not to damage the metal core.

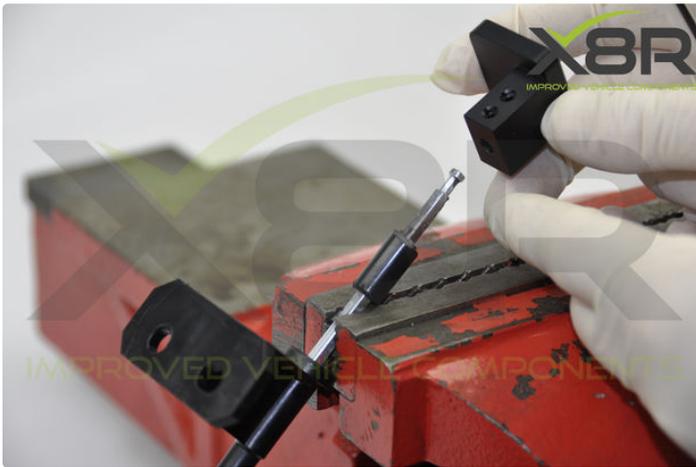
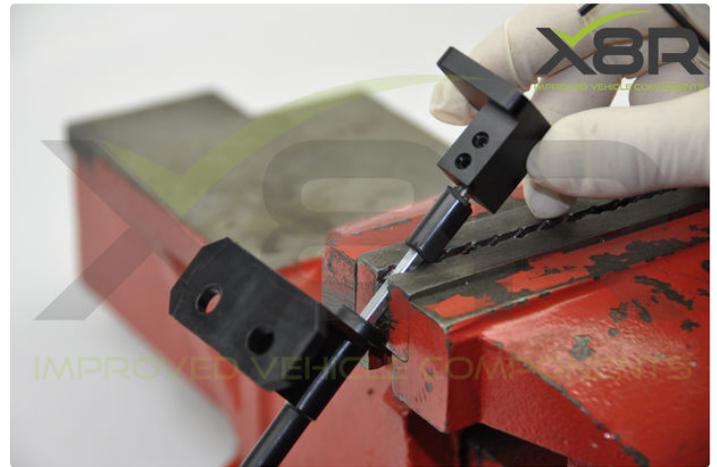
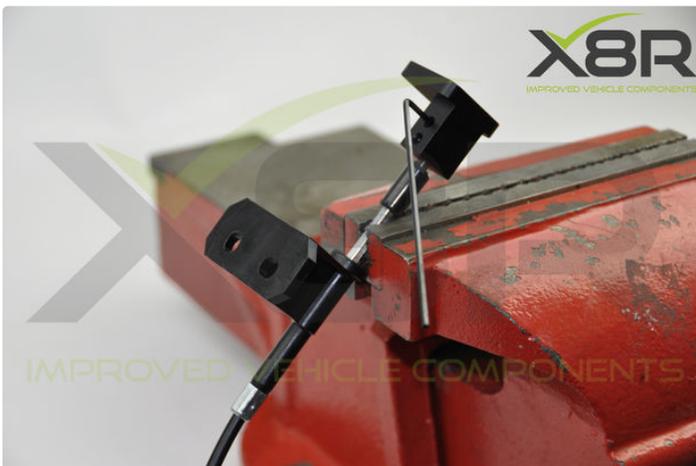
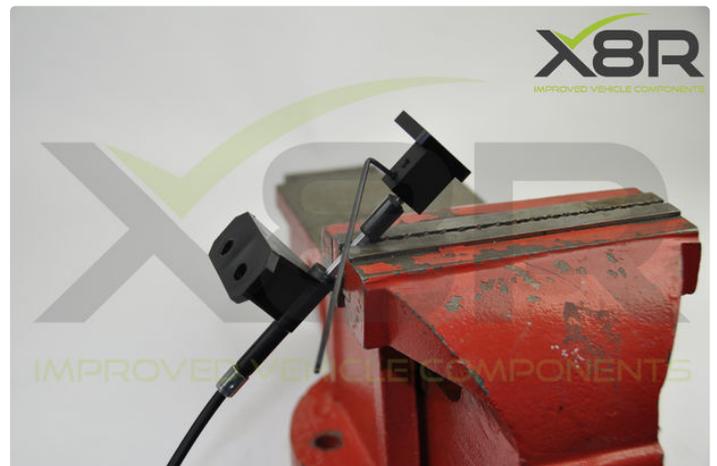
Step 2: Fit Our New Handle

Slide our handle over the metal core of the rod and fasten the two set screws using the allen key to secure the handle tightly to the rod core.

This will restore function, test the operation and further tighten the set screws if required.
