Mercedes Benz Keyless Go Entry Door Exterior Handle Push Lock Button Square Cover Rubber Plastic Repair Kit Install Instructions

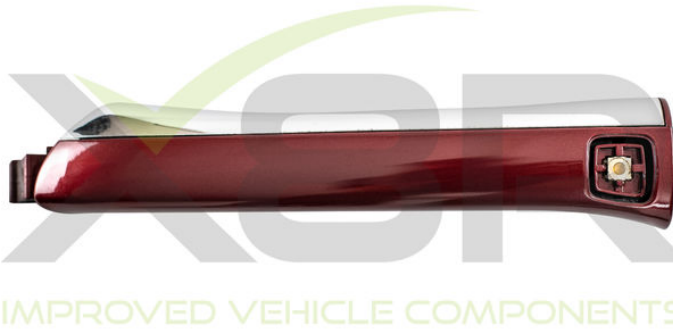
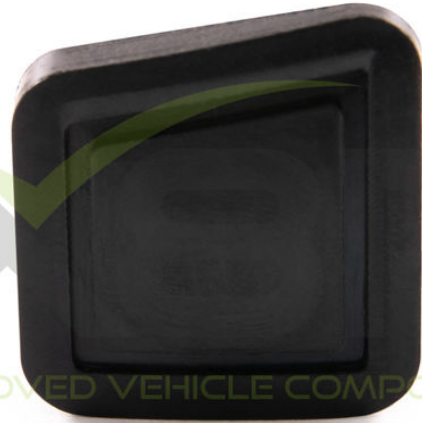
Fit our replacement button in situ, instantly improving the look of the door handle.

The dealer will suggest the handle needs replacing, this is extremely expensive (often needing colour coding), laborious to fit and would wear and fail again. Our solution can be installed in situ, fitting in the same way as the original; instantly improving the look of the handle and restoring the sealing function.

It is common for the Keyless Go door handle rubber button to wear spoiling the look of the door handle.

It is very common for the small black rubber Keyless-Go button on these vehicles door handles to fail. The poor-quality OEM rubber is not suited to the wear / varying temperatures that this part experiences.

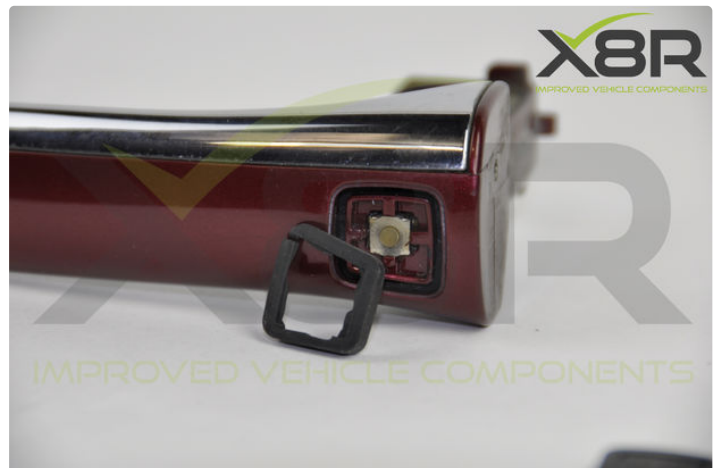
Step 1: Remove the Remaining Pieces of the Old Button

The remnants of the old button can sometimes be removed just pulling it out. Often, a Stanley blade, small flat head screwdriver or long nose pliers may be needed to remove the old rubber from within the groove.

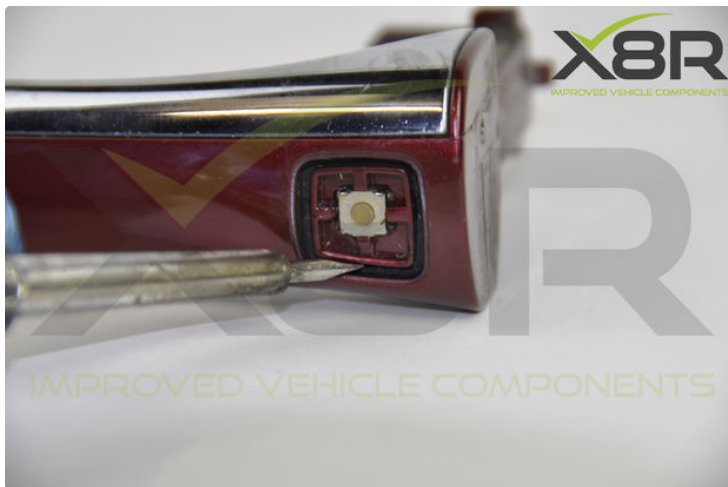
Step 2: Remove Any Glue Residue

Once the old rubber has been removed, the groove should be cleaned out to remove any glue residue. This can be done with a small flat headed screwdriver or a Stanley blade.

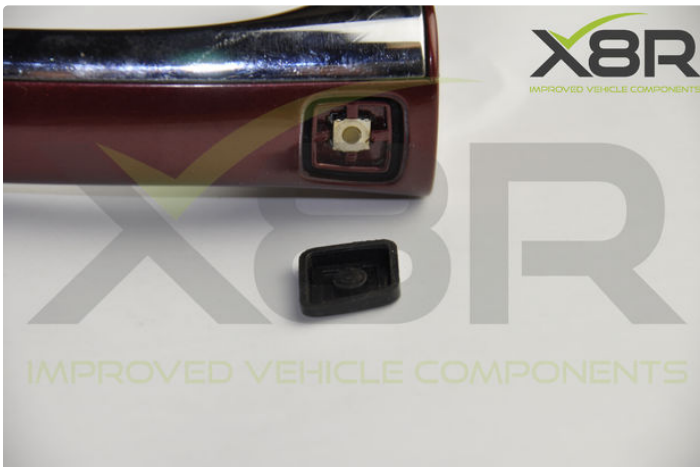
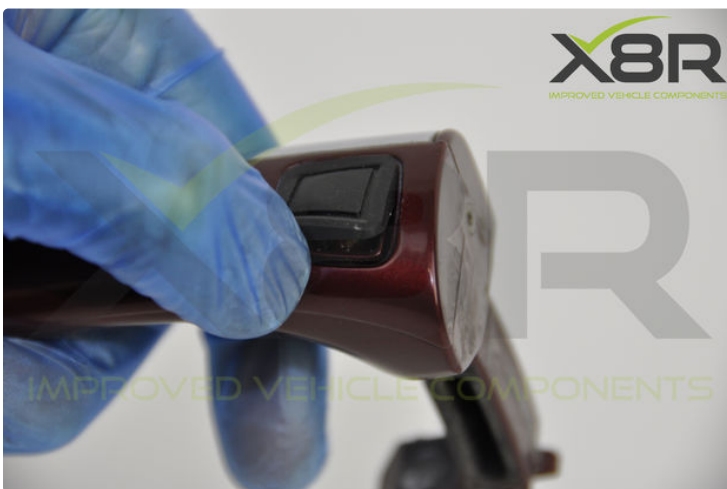
Step 5: Offer Up and Insert the New Button

Offer up the button to the handle to make sure the orientation is correct. If you are happy, proceed to place the button edges into the groove and then push down so that the button pushes into the glue and sticks firmly in place.

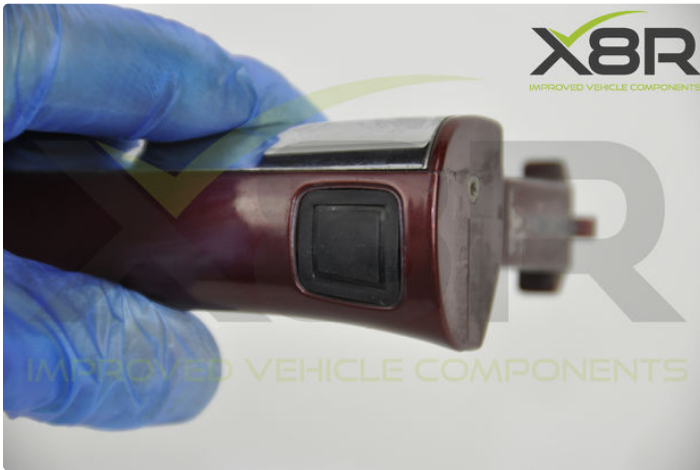
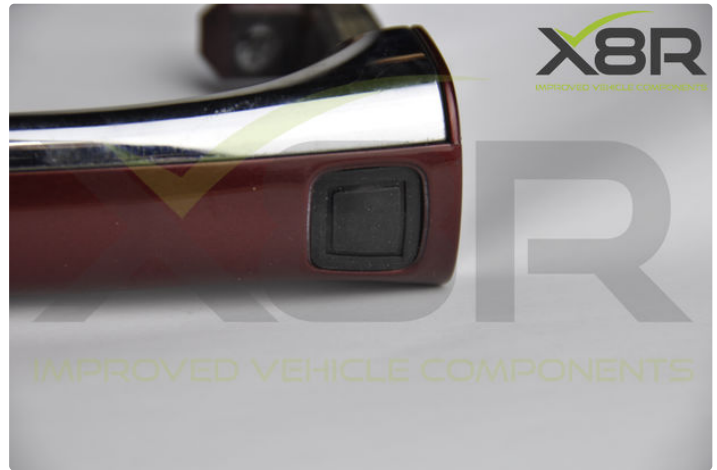
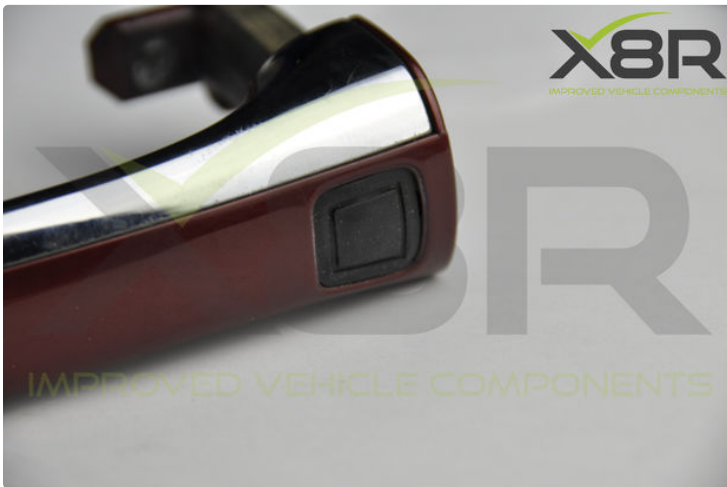
Step 6: The Finished Article

This completes the repair. If you need any further guidance on this install or would like to purchase the parts shown please call us on +44 01843 446643 or email us at sales@x8r.co.uk. Please also check out our instruction guide on YouTube.
