BMW 6 Cylinder M52TU, M56, and M54 Dual / Twin / Double Vanos Rattle Repair Fix Process Instructions

Intro: BMW 6 Cylinder M52TU, M56, and M54 Dual / Twin / Double Vanos Rattle Repair Fix Process Instructions

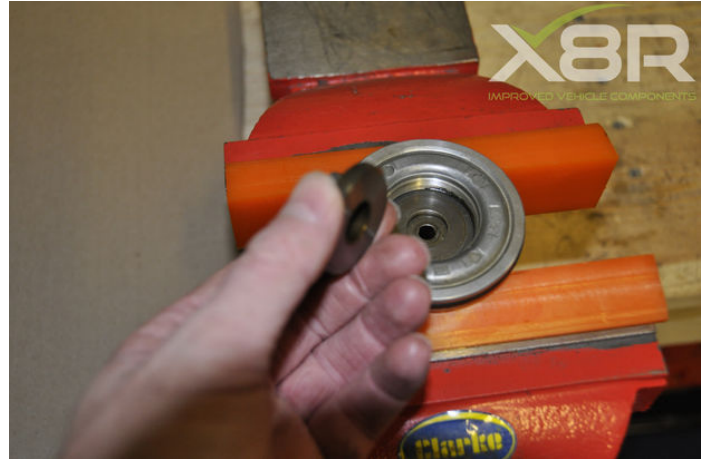
Step 2: Remove piston bolt

Remove piston and insert in to vise with soft jaws. Please note using vise without soft jaws WILL damage piston beyond repair. Only use 100% nylon soft jaws.

Loosen 24mm piston bolt with impact wrench, do not push down on wrench and use in lowest setting. Once bolt is removed loosen vice grip.

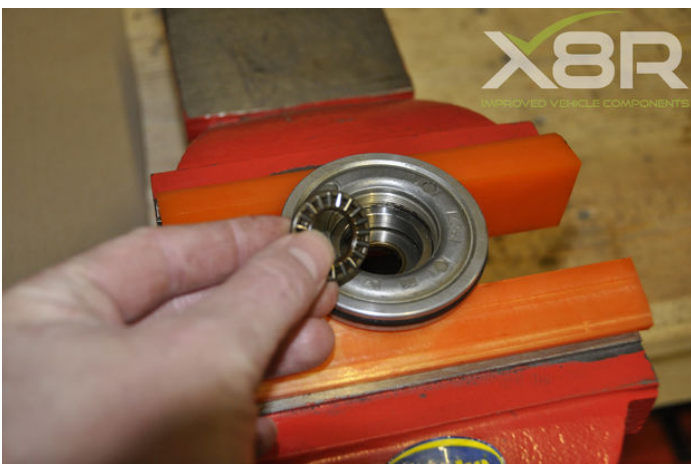
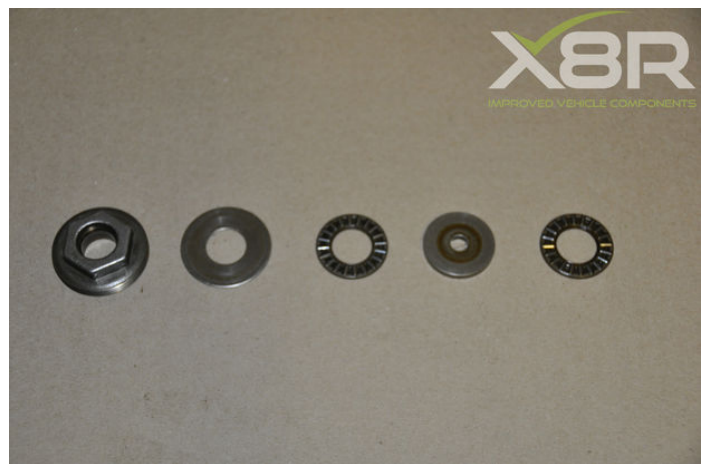
Step 6: Remove bottom bearing

Remove bottom bearing.

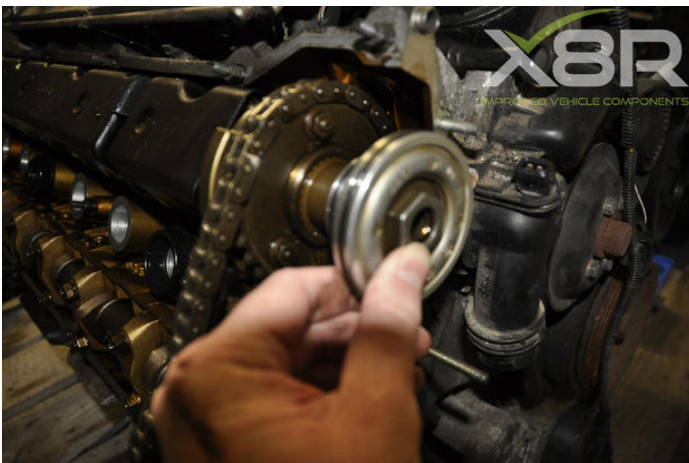
Step 11: Refit piston and test

Refit piston to intake splined shaft with piston mounting bolt (remember piston mounting bolt is left hand thread). Inspect piston axial play. Hold shaft and try to rock piston and note in/out movement.

If piston cannot be rotated or doesn't rotate easily axial fit is too tight and adjustment is needed. Disassemble piston again and locate bearing center washer. Place 400 grade sandpaper on flat surface and place washer flat on this. Push center washer up and down lightly for 10 seconds and repeat on other side. Reassemble piston and check axial movement, repeat process if necessary.

If piston rocks and there is in out movement axial play is still an issue and adjustment is needed. Disassemble piston again and locate bearing ring. Place 400 grade sandpaper on flat surface and place bearing ring flat on this. Push ring up and down lightly for 10 seconds and repeat on other side. Reassemble piston and check axial movement, repeat process if necessary.

Once fit is correct spray oil in to piston before refitting.
