BMW X3 X5 X6 Gear Box Transfer Case Servo Actuator Motor Repair Gear Installation Instructions Guide.

Intro: BMW X3 X5 X6 Gear Box Transfer Case Servo Actuator Motor Repair Gear Installation Instructions Guide. Symptoms:

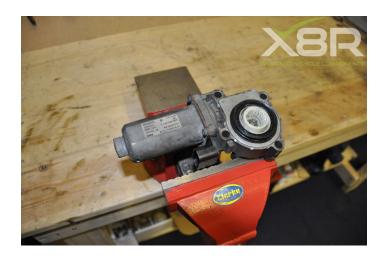
Step 1: Note orientation of components

Take note of the position of all parts of the actuator, refer back to image for reinstallation.

Note resistor on back of actuator, take care not to damage when carrying out repair, (removal is recommended for repair)

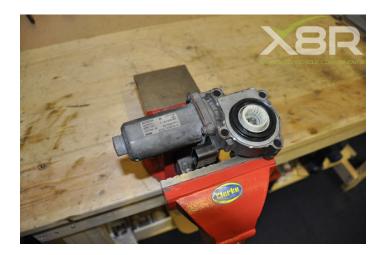
Step 2: Remove motor
Unscrew 4x bolts and remove motor body.

Remove plastic module noting orientation and remember to locate seals on either side of module for reinstall.

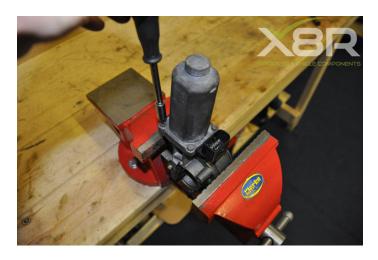
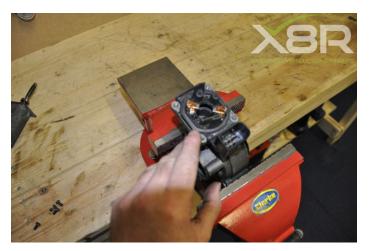
Step 3: Remove C Clip

Remove retaining C clip, this can be done with a combination of screw drivers. The easiest method we have found is to use circlip pliers to open the C then inserting a small flat head screwdriver in the space created at the top of the C to allow removal.

Remove washer.

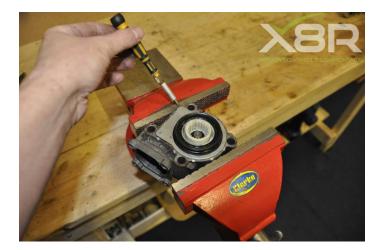
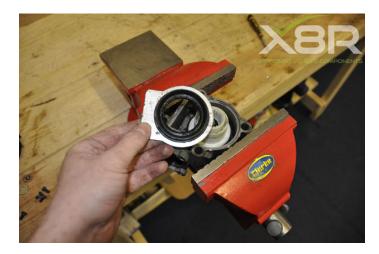
Step 5: Clean all components
Clean up module and motor points with compressed air or suitable cleaner.

Remove gear and clean all components of actuator housing.

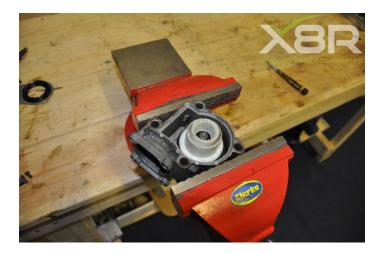
Step 6: Fit new gear
Grease up new gear and replace worn gear.

Attached to the transfer case is an actuator motor, within in this there is a poor quality Nylon plastic gear, this is turned by a metal worm gear. Over time the Nylon wears down and strips and leads to the gear not turning; this results in the symptoms noted above. BMW do not supply this part as a spare, they will provide at vast cost a

Grease worm gear and gear shaft.

Refit gear.
