Nissan Micra K12 Upgrade Front Wiper Motor Linkage Repair Replacement Push Rod Rods Set 2003-2010 Instruction Guide Install

Intro: Nissan Micra K12 Upgrade Front Wiper Motor Linkage Repair Replacement Push Rod Rods Set 2003-2010 Instruction Guide Install

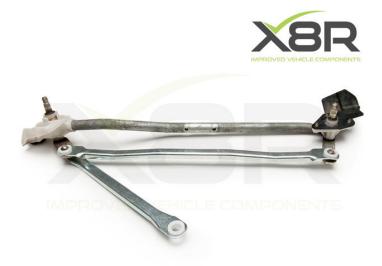
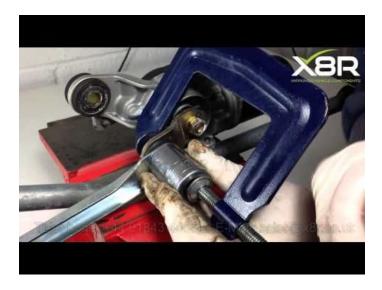
The symptoms of this fault are very obvious; windscreen wipers simply not working, there's only one windscreen wiper working or the windscreen wiper movement is erratic or juddering with the wiper link popping off frequently.

The original soft plastic bush bearings on each end of the two wiper linkage push rods wear down leading to the push rods popping off of their respective ball joint. Dependent on which rod pops off or if the rods haven't popped of but there is excess movement in the joint this will cause the symptoms noted above. It is a very common fault on this model. Until now it has only been possible to buy a whole new wiper mechanism at vast cost which would just fail again

Our high quality new rods simply replace the original worn out rods; this is a very simple process, with full instructions included. Save the cost of a complete replacement mechanism that would just fail again. Our rods are fitted with upgraded high quality plastic bearings giving a smoother and more reliable wipe, a vast improvement over the OEM part, designed to last the life of the vehicle not the life of the vehicles warranty.

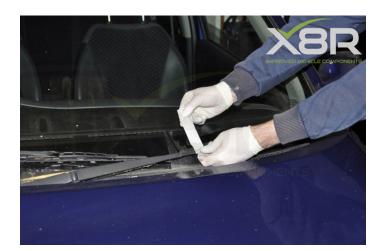
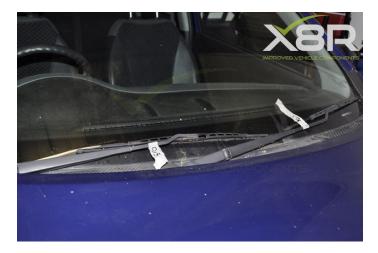
Step 1: Label the wiper arms
Wrap masking tape around the wiper arms and label them n/s for passenger side and o/s for drivers side. This is key for the re-fit to ensure the correct arm is on the correct spindle.

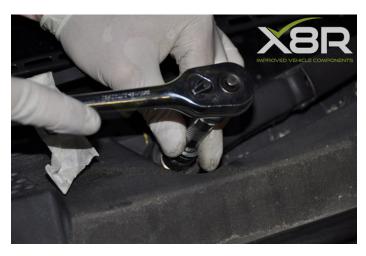
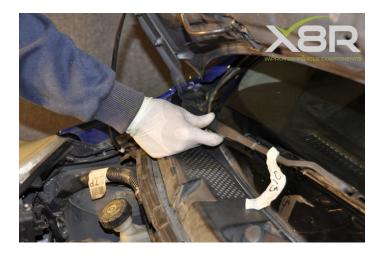
Step 2: Remove the wiper arms
Using a flat bladed screw driver remove the caps on the wiper arms to reveal the nuts.

Remove the 14mm nut from each arm.

Once the nuts are removed from the arms pull on the arms to remove from their spindle.

If the arms can't easily be removed re-fit the nuts. With the nuts re-fitted shock the nuts using a small hammer or mallet to shock the arms free, the arms will now be free to be removed.

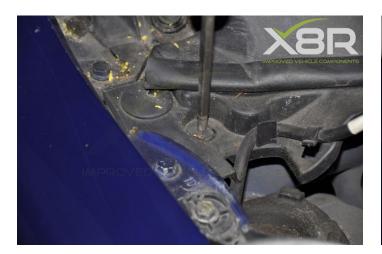
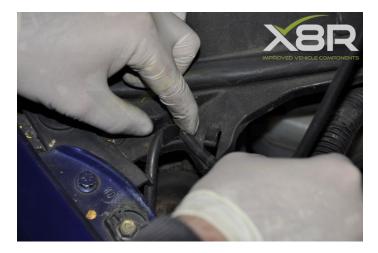
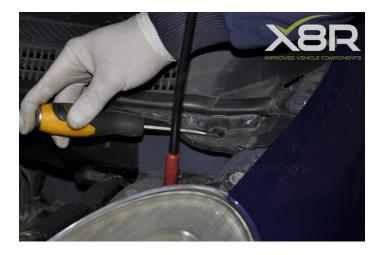
Step 3: Remove the scuttle panel
Remove the two Philips screws from each side of the scuttle. It is also worthwhile removing the locator part of the screw using a flat bladed screw driver.

On the n/s (drivers side) of the car the washer jet pipe work is clipped on to the scuttle panel; this needs to be un-clipped and set clear for removal of the scuttle.

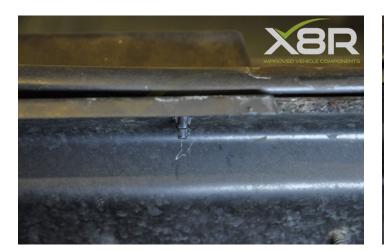
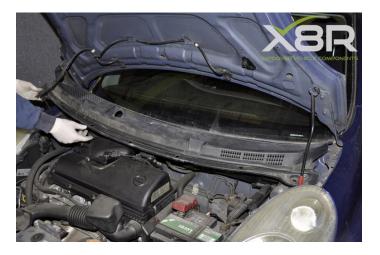
On the lower half of the scuttle panel there are little clips holding the panel in place. Using a small pair of grips or pliers grip the clip and using a flat bladed screw driver or pry bar lever the panel up to pull the clip through the locator hole. Repeat for all clips.

Once all the clips have been removed the scuttle panel is free to be removed.

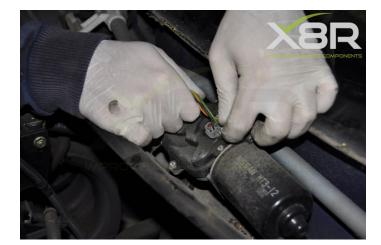
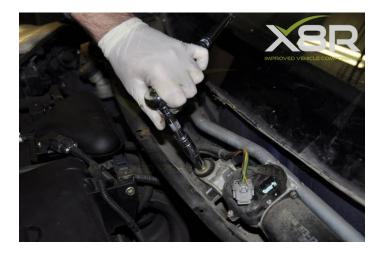
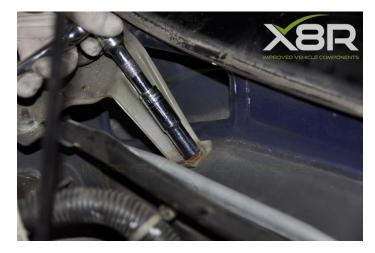
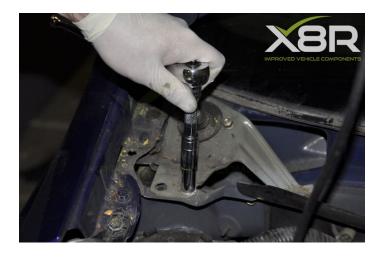
Step 5: Remove the wiper motor and linkage Unplug the wiper motor and tuck the wires / connector out of the way.

5 bolts and 1 nut need to be removed to be able to remove the linkage from the vehicle. 3x 10mm bolts on the motor side of the linkage and 2x 10mm bolts and 1x10 mm nut from the other side.

Once all bolts and the nut are removed the linkage is free to be removed from the vehicle.

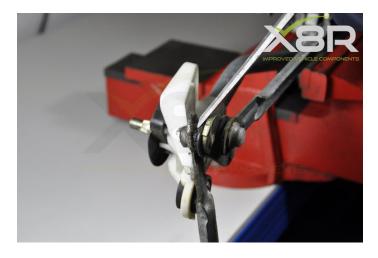
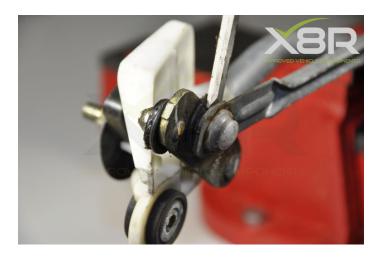
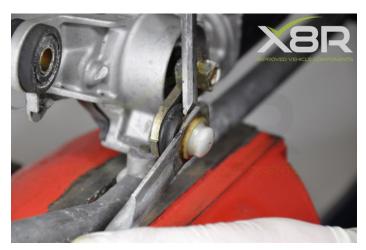
Step 6: Remove the old wiper linkage push rods
Using a flat bladed screw driver or a pry bar lever the old wiper linkage rods off. Some will have likely already popped off others are likely to be worn and as such will pop off easily.

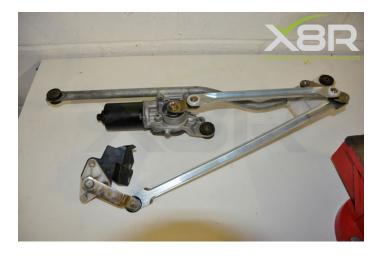
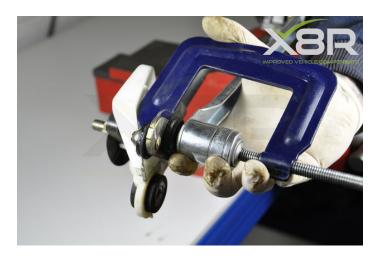
Step 7: Fit our new linkage push rods
Please note the image showing the correct orientation of the new push rods.

Please follow the below to attach the rods to the ball joints:

Position the bush at the end of our push rod over the ball joint, place a 22mm socket over the bush, using a G clamp as shown wind the G clamp in; pressing the bush over the ball joint. You will hear a click sound once the bush is fully engaged and secured on the ball joint.

Repeat this process for all 4 bushes.

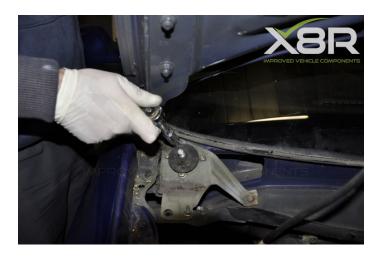
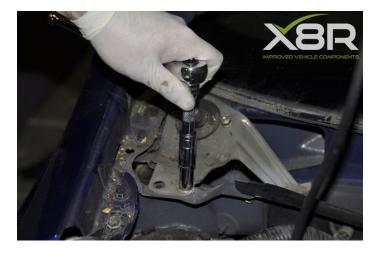
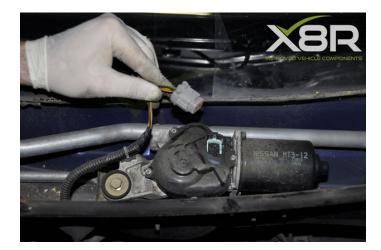
Step 8: Refit the linkage to the vehicle
Slot the linkage back in to the vehicle and re-fit the bolts and nut finger tight; this will allow you to move the linkage slightly until seated correctly, you can then fasten the bolts and nut up tight.

Plug the electrical plug back into the wiper motor.

Test the wiper linkage to ensure that all is functioning correctly.

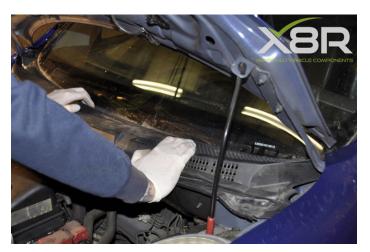
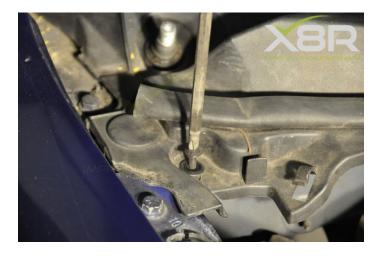
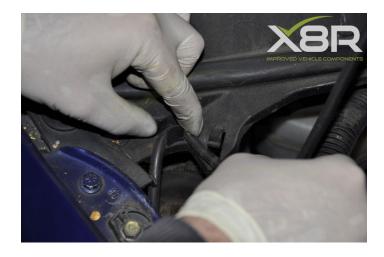
Step 9: Refit the scuttle panel Slot the scuttle panel back into position.

Insert the locator part of the screw back in on both sides and refit the screws.

Refit the clips back in along the scuttle panel.

Refit the pipe work for the washer jets.

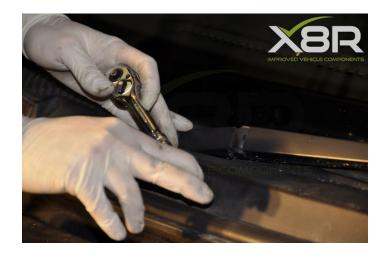
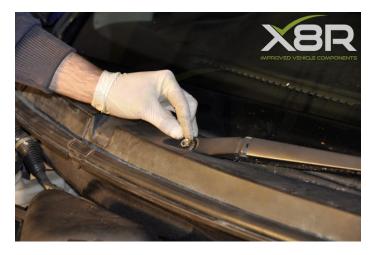
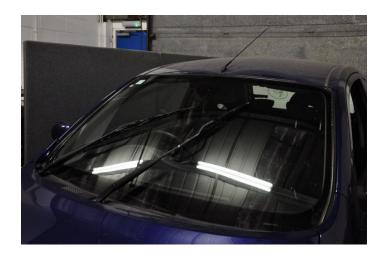
Step 10: Refit the wiper arms
Refit the wiper arms and tighten the nuts.

Refit the plastic nut covers.

Test the windscreen wipers.
