Vauxhall Opel Holden Astra Twin Top Convertible Roof Parcel Shelf Winglet Flap Motor CNC Brass Gear Repair Fix Kit Install Guide Instructions

The Problem

The plastic gear within the parcel shelf winglet motor wears and strips causing roof faults.

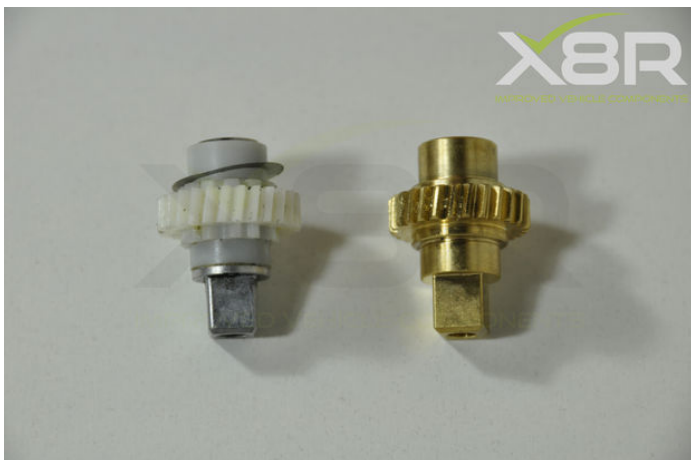
1x Brass CNC machined parcel shelf winglet gear. This is not a cheaper cast part, this is a CNC part produced to fine tolerances.

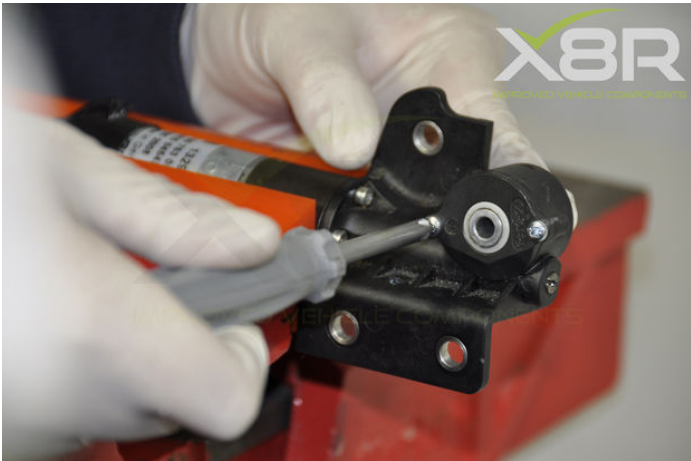
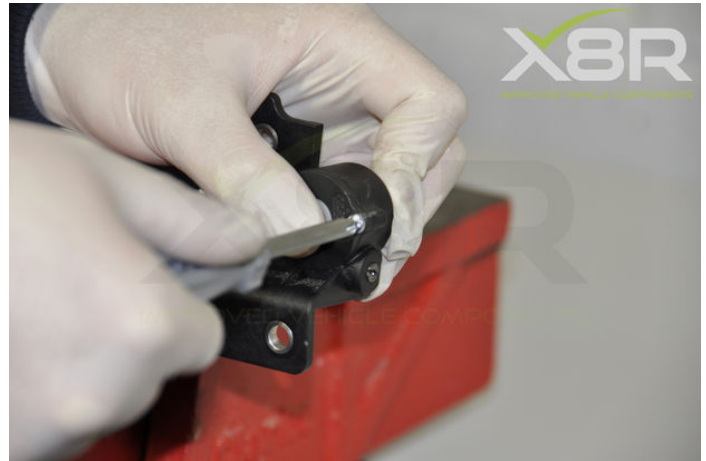
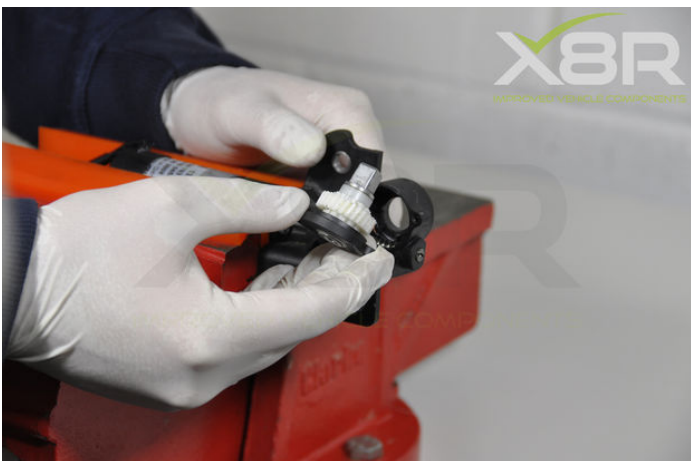
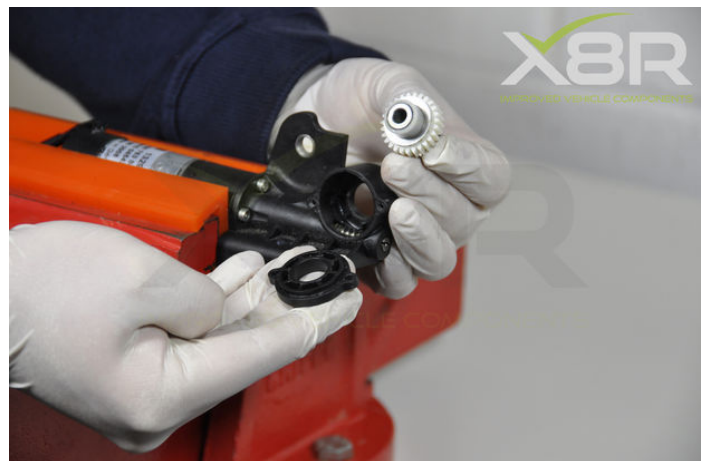
Step 3: Remove the motor cover and the old gear

Sometimes the gear will come out with the cover.

Remove the 2x Philips screws from the cover.

Lever off the cover.

On top of the old gear there is a metal washer remove this as this is needed when fitting the new gear.

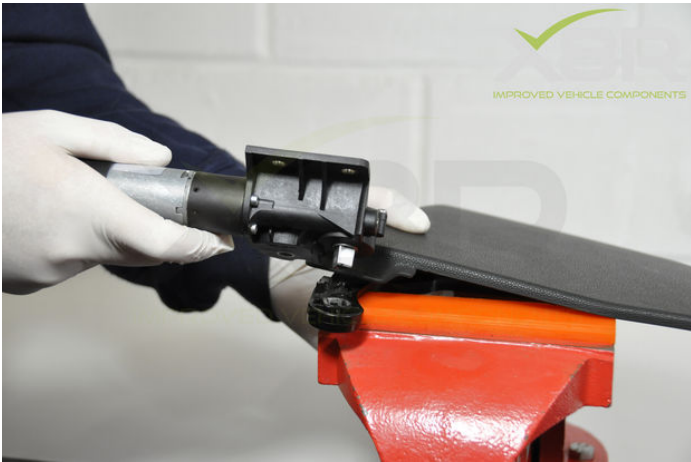
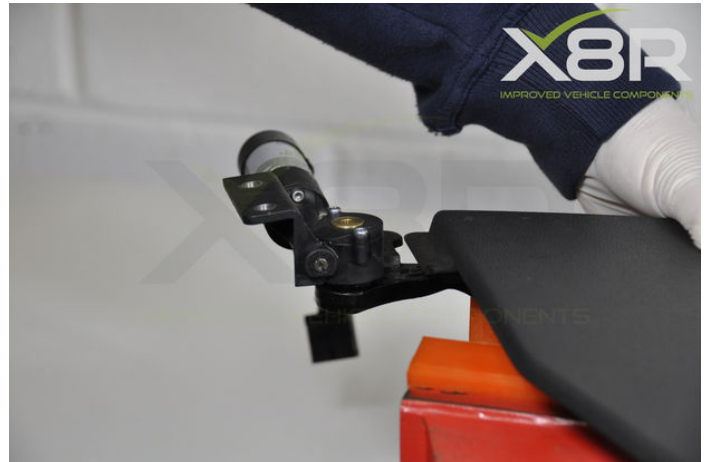
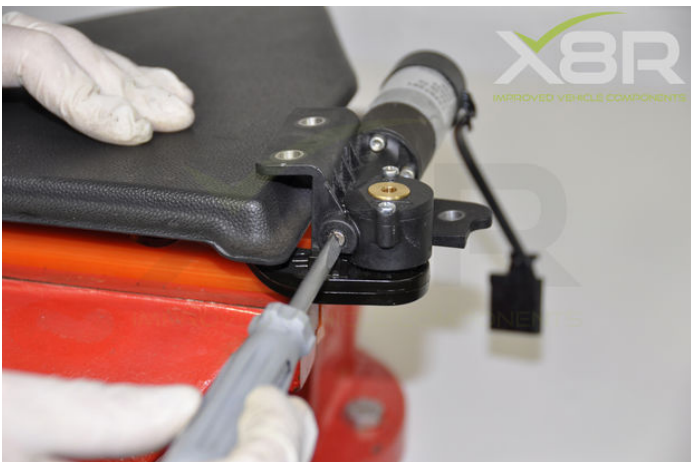
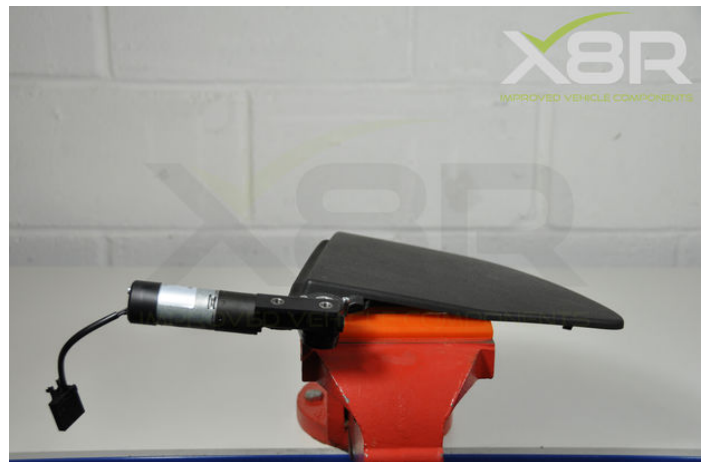
Step 5: Test function

On the side of the motor is a flat headed screw; this allows you to manually adjust/move the gear. You can test the gear and see that it is functioning correctly by rotating the screw.

Slot the motor back onto the parcel shelf flap and reattach the screw securing the two.

If you need to adjust the angle of the flap wind the screw to get the flap to the desired position. The flap needs to be in the fully extended position when refitting to the vehicle.

Refit the flap and motor unit to the vehicle and test operation.
