## Vauxhall Opel Combo Corsa C Meriva Tigra Corsavan Gear Selector Mechanism Linkage Rod Repair Kit Instructions Install Guide

by x8rltd

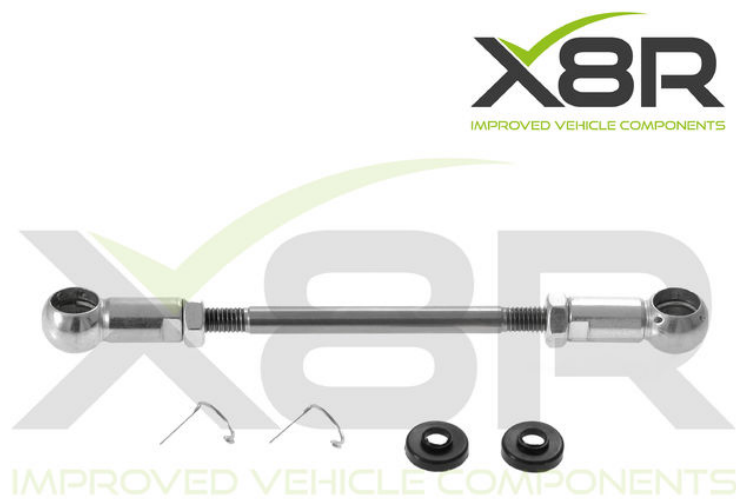
You will receive

1x Linkage arm with metal ball joints and locking pins

2x Rubber grease seals for ball joints

Our improved design metal push rod arm with metal ball joints very easily replaces the failed plastic part, restoring gear function for the life of the vehicle.

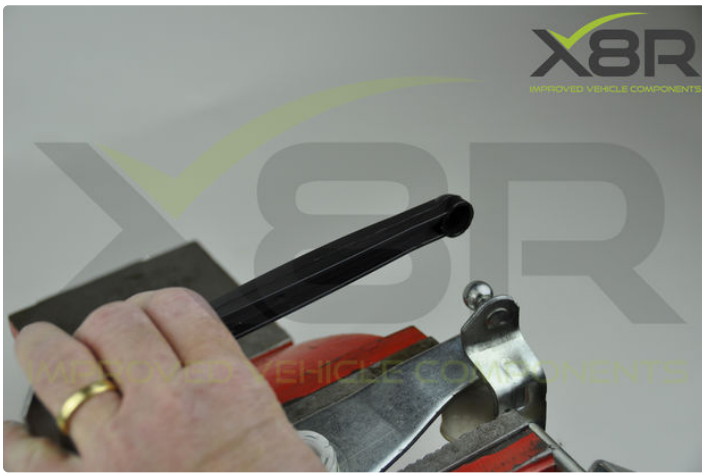
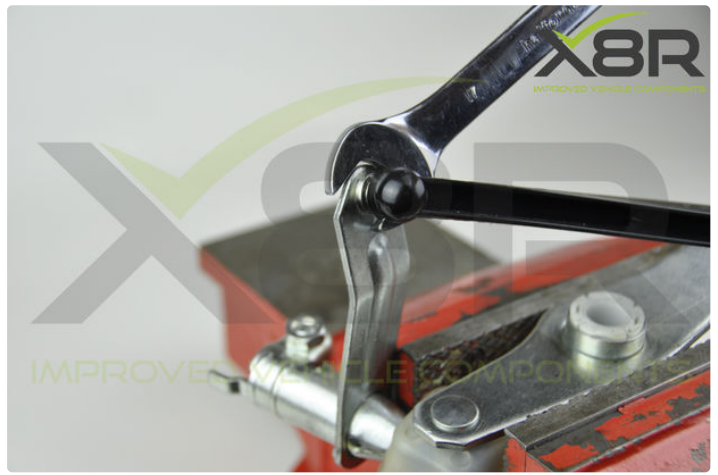
## Step 1: Locate and Remove Plastic Linkage Rod

Locate the gear linkage mechanism on top of the gearbox.

If either end of the plastic rod linkage is still in place, use a spanner or pry tool to lever off of the ball joint on the linkage mechanism.

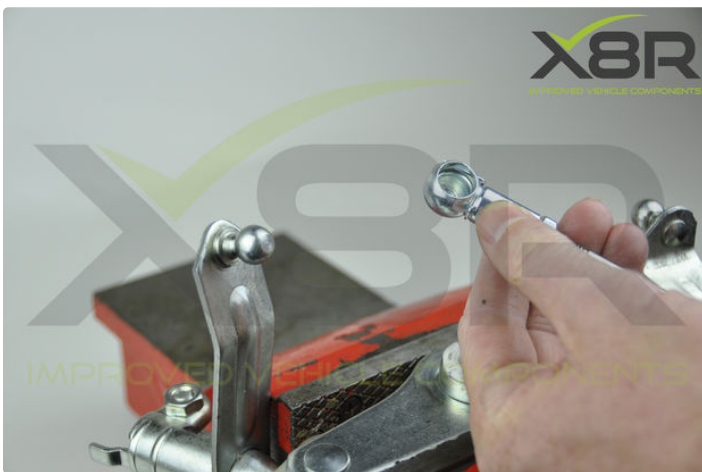
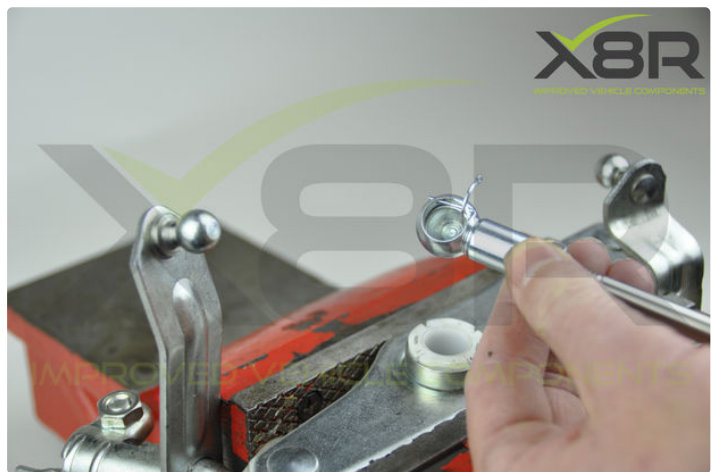
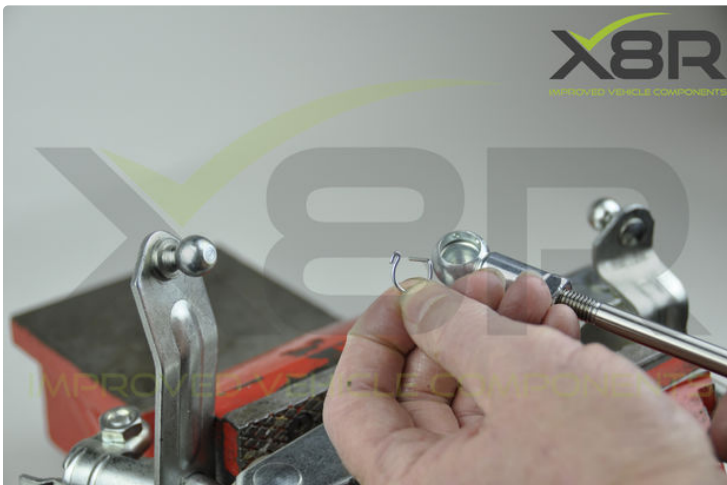
## Step 2: Remove Locking Pins From Our Linkage Rod

On both ends of our linkage rod remove the locking pins.

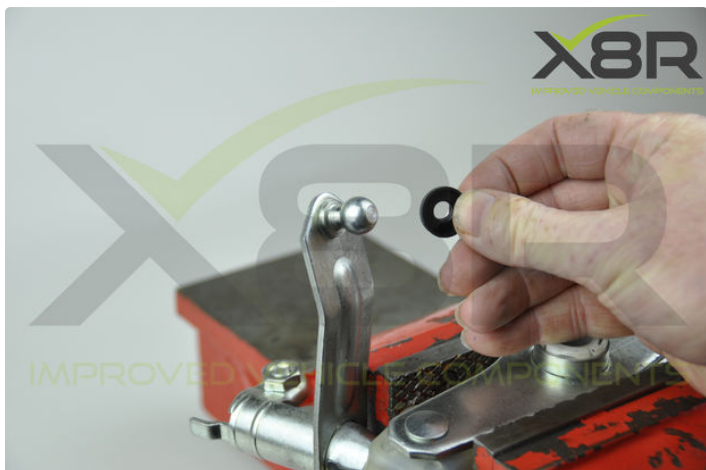
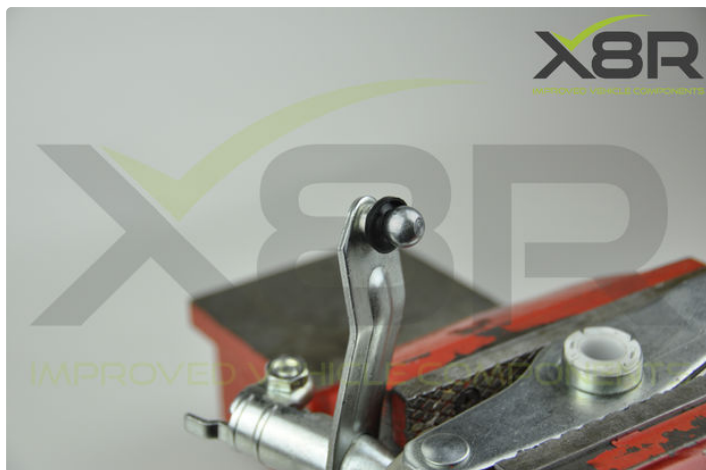
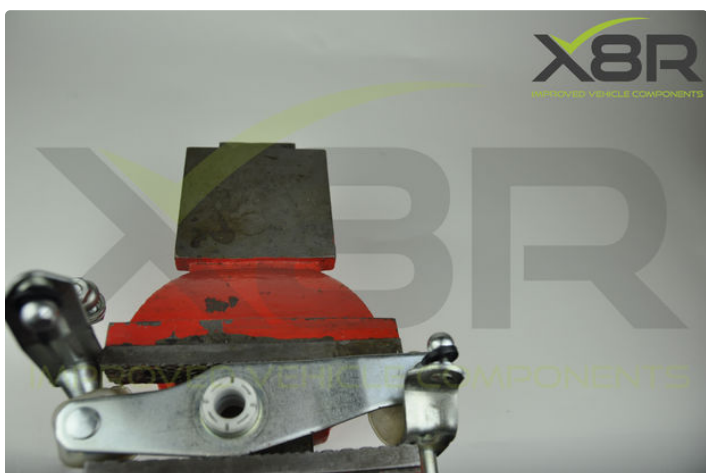
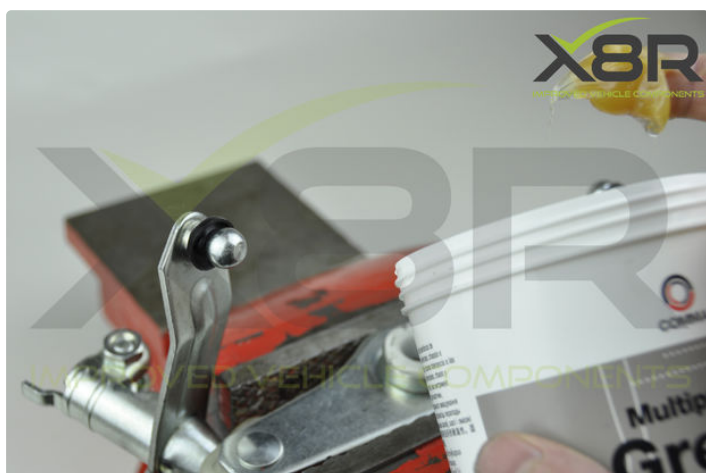
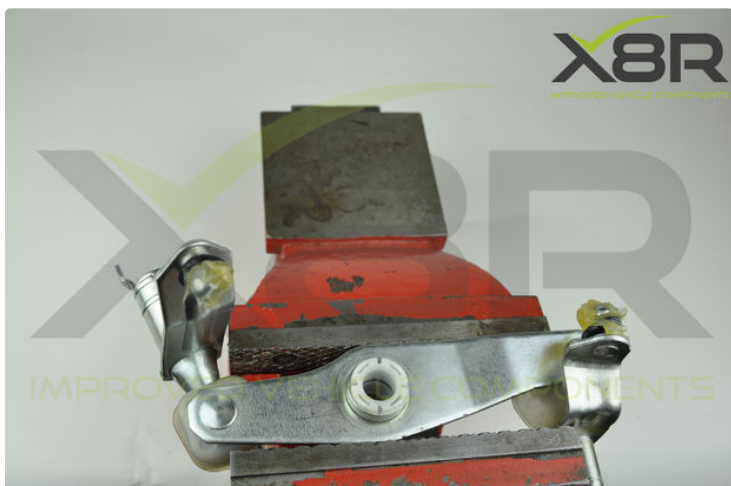
### Step 3: Attach Grease Seals and Lubricate Mechanism

Push our rubber grease seals on to the two ball joints on the mechanism.

Grease both ball joints.

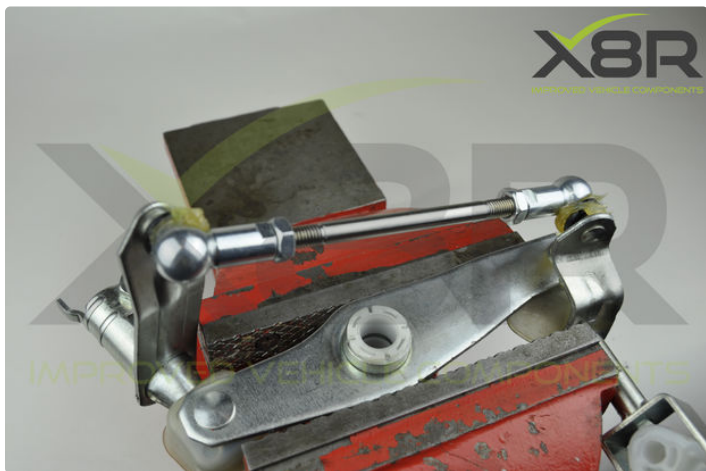
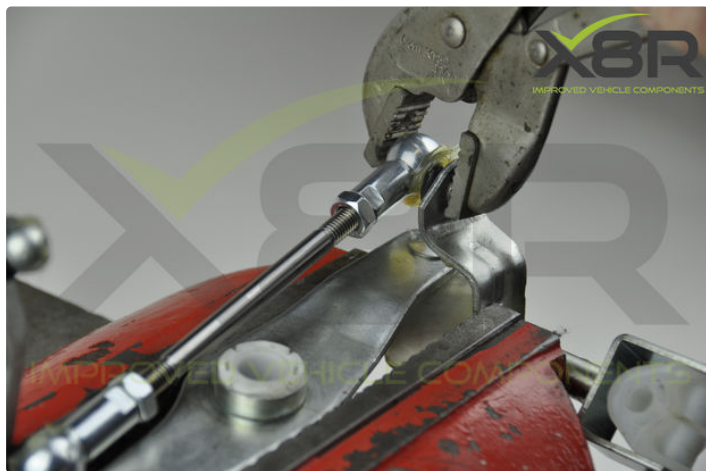
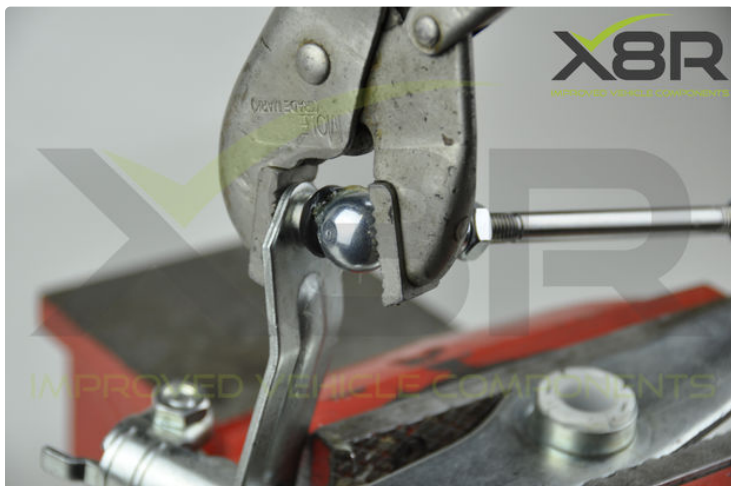
## Step 4: Push Fit Our New Linkage Rod

Locate our linkage rod on to the ball joints.

Our linkage comes pre-configured to the same spec as OEM, however the length of the rod and angle of the ball joints can be adjusted.

Using a pair of grips click the ball housing ends of our rod on to the ball joints.

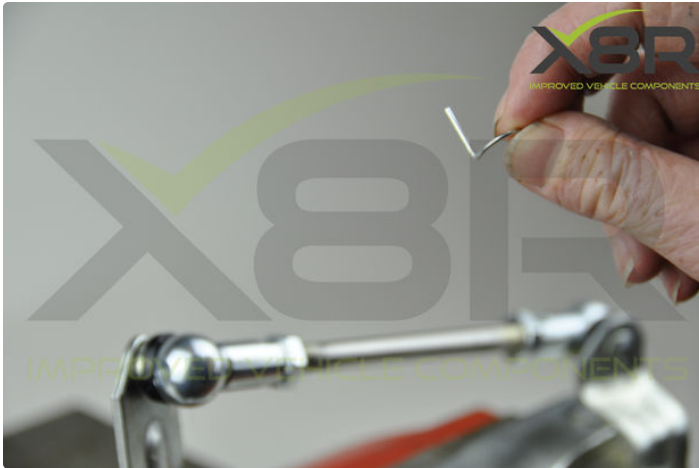
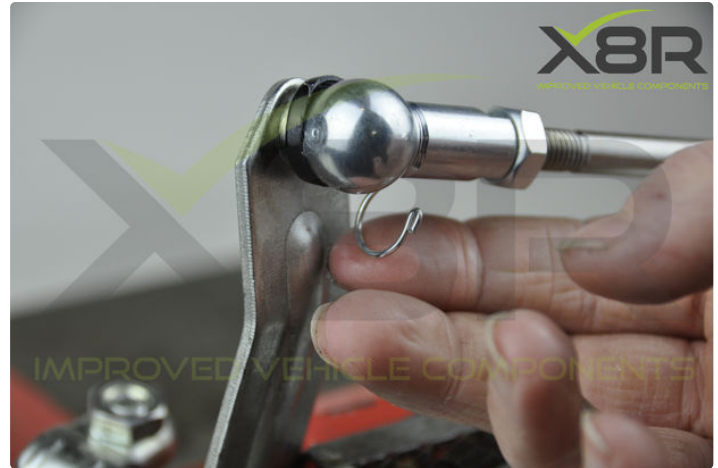
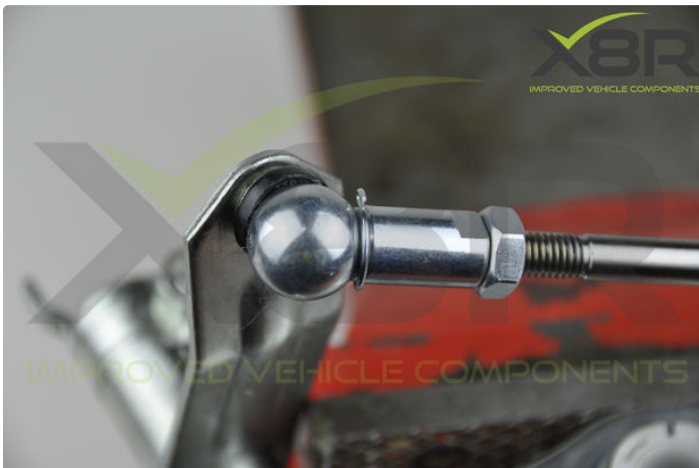
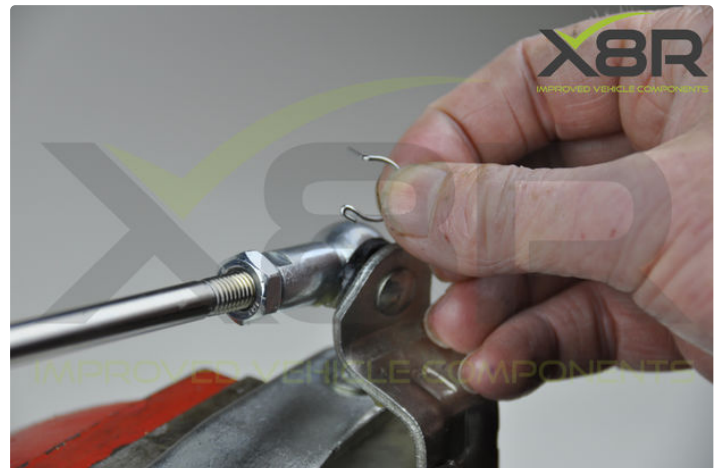
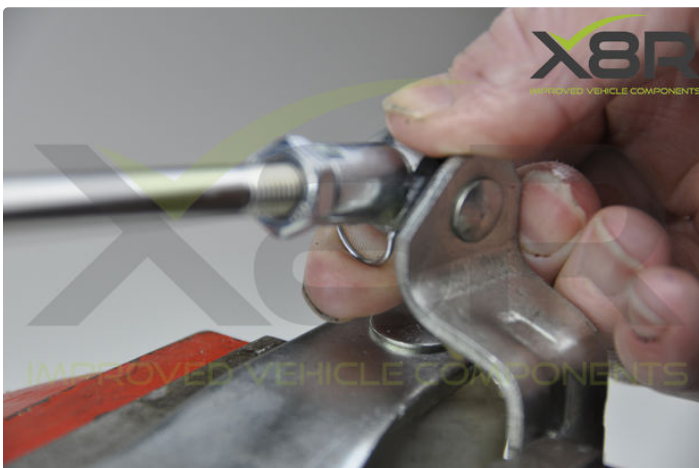
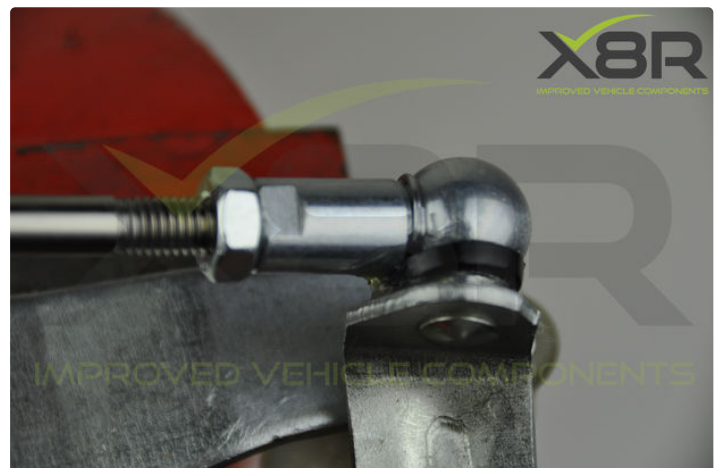
## Step 5: Fit the Locking Pins

Refit the locking pins as shown.

Test gear operation.
