# Mercedes C E CLK W203 W211 W209 Class Door Lock Actuator Spring Repair Instructions Front Door

## Introduction

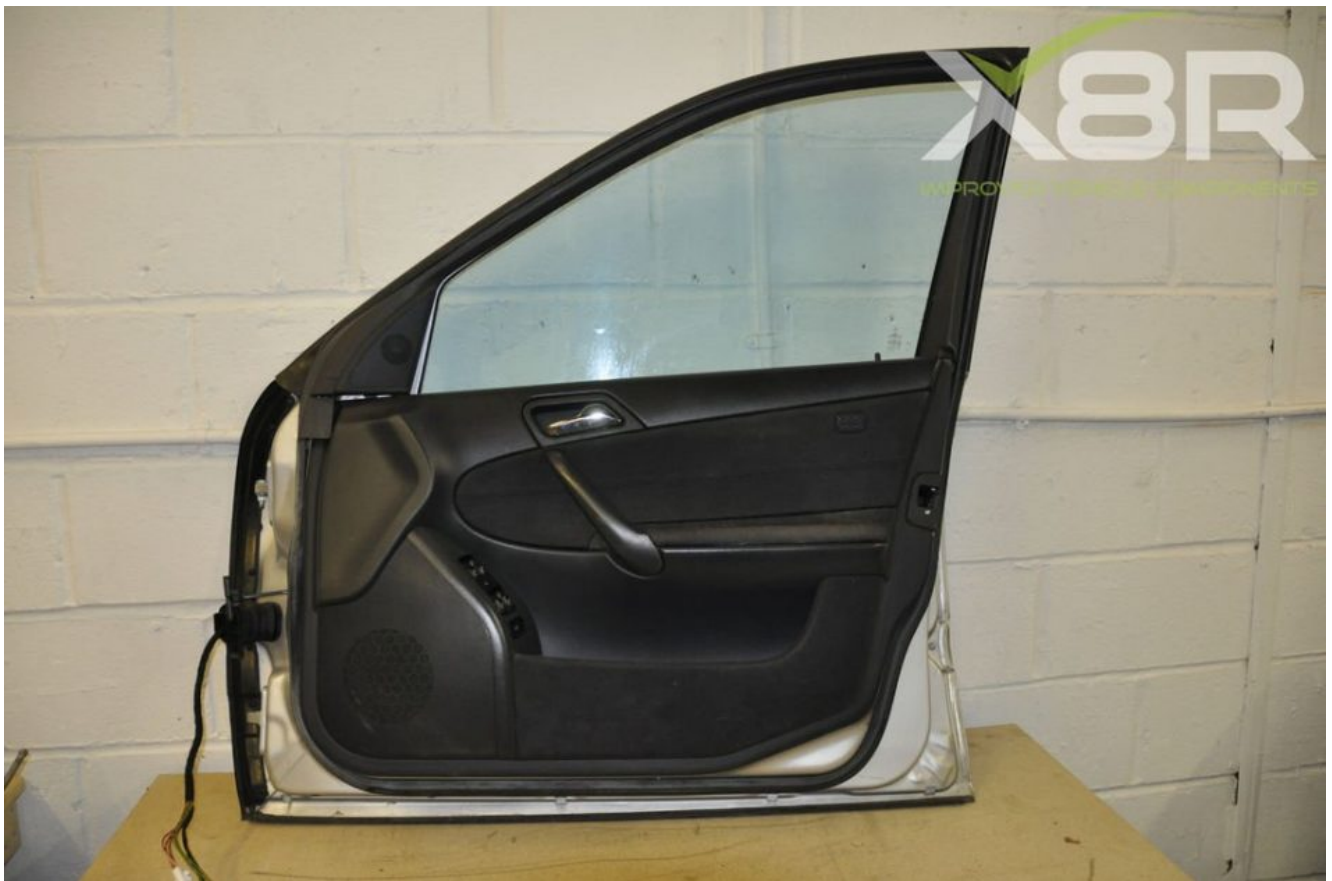
The Springs within the door lock actuator mechanisms deteriorate over time, the OEM spring is made from cheap metal which wears quickly, this wear leads to the symptoms noted above.

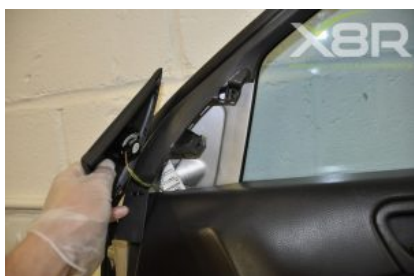
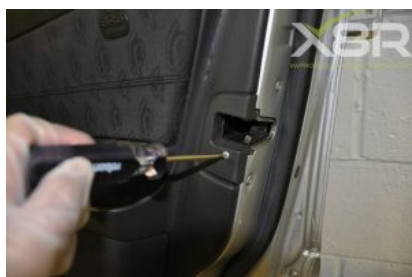
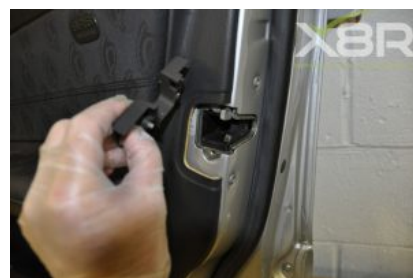
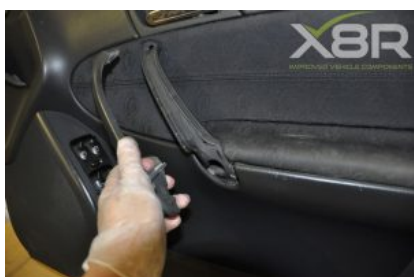
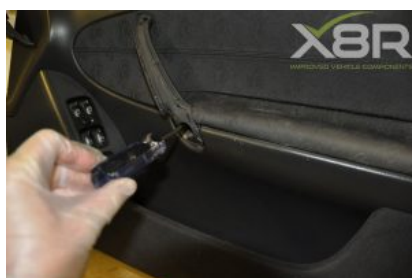
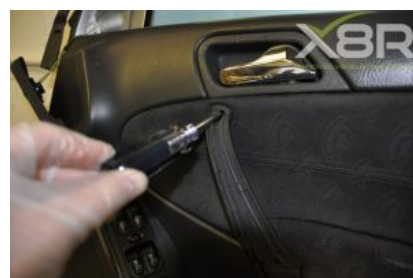
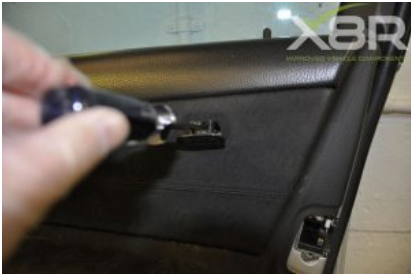
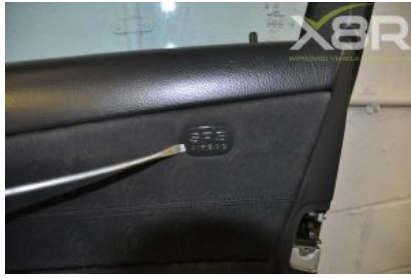
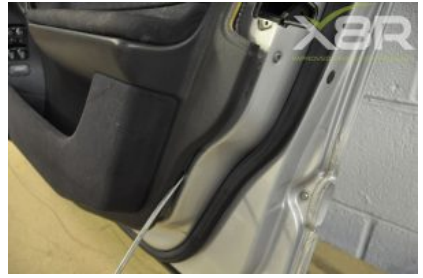
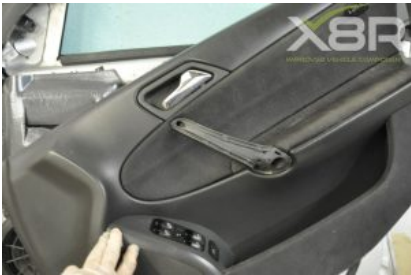
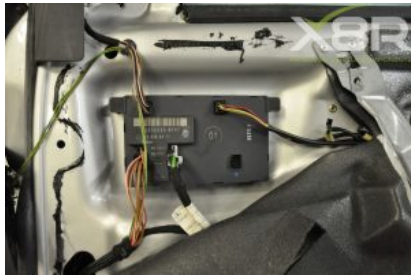
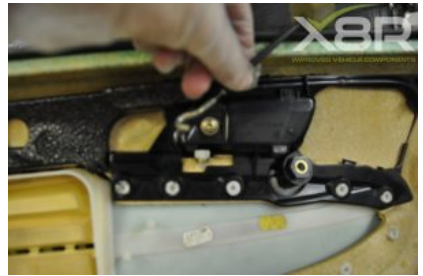
## Step 1: Remove door trim

Remove speaker.

Remove T20 torx and remove lock cover.

Lever off the cover from the door handle.

Remove the two torx bolts under the handle cover (T25, T30)

Lever off SRS badge and remove Torx beneath.

Lever around the edge of the door trim and lift off.

Pull upwards and forwards on the door trim to remove.

Remove electrical connectors.

Disconnect hook linkage.

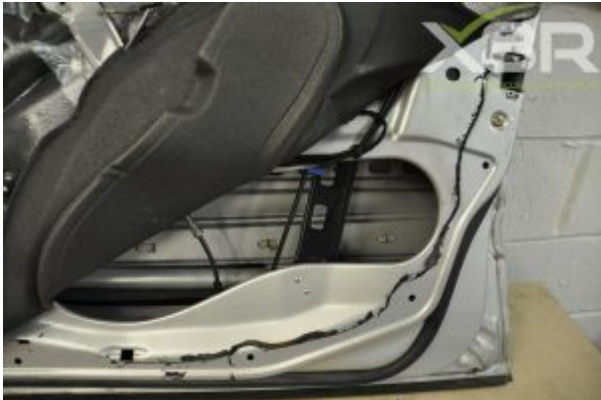
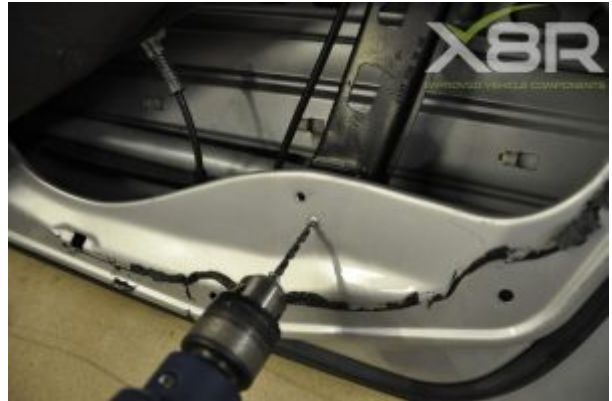
## Step 2: Loosen window guide

Peel back insulation to reveal rivets holding window guide.

Drill out two rivets from window guide (for re-installation you can use our fixings included in our kit)

For re-installation the window guide can be riveted back in to position or can be fixed using the fasteners included with our product.

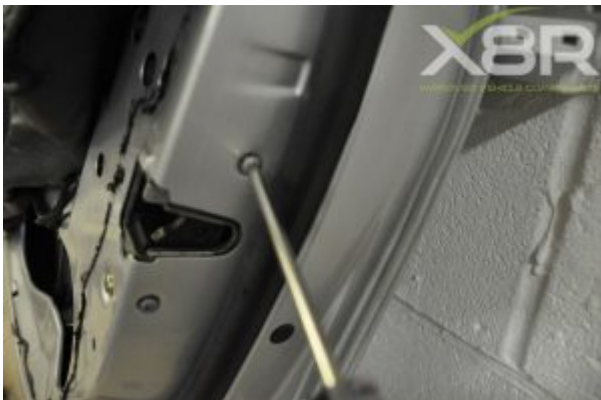
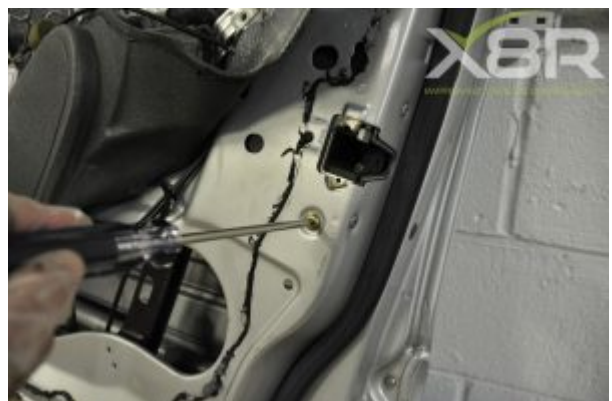
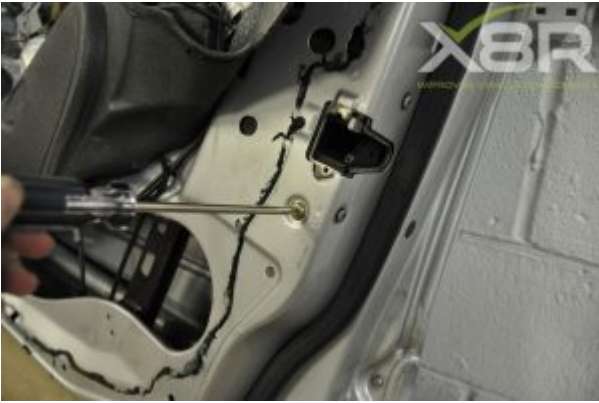
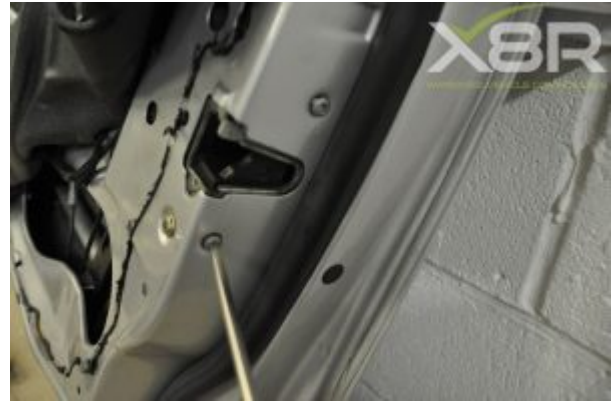
## Step 3: Release actuator

Remove the 3x T30 Torx screws holding the actuator.  
If present remove plastic cover.

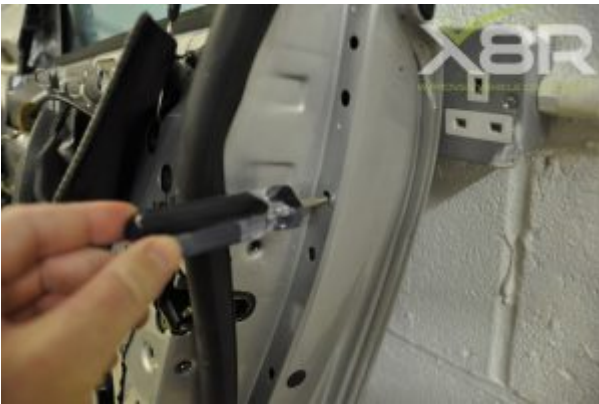
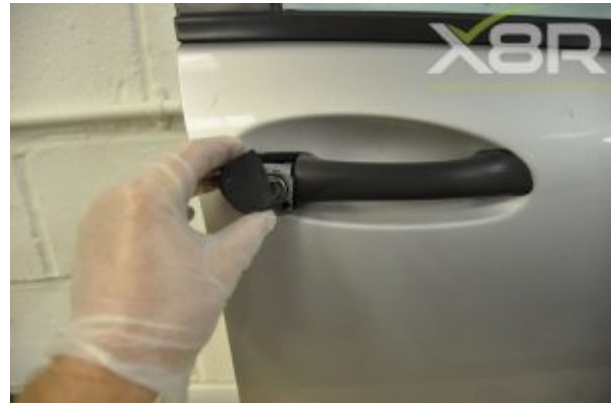
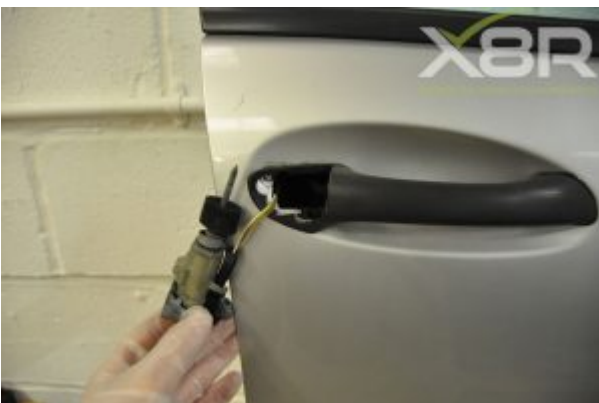
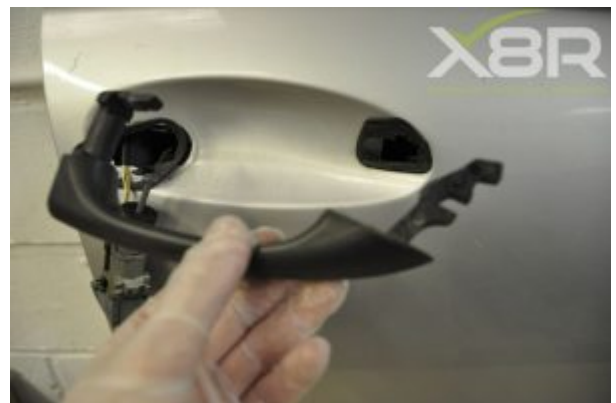
## Step 4: Remove outer handle

Remove blanking plate and unscrew T20 torx holding outer door handle.

Remove handle, firstly remove small part of handle released by removing the previous T20 Torx then slide handle in to recess left from this to release from vehicle.

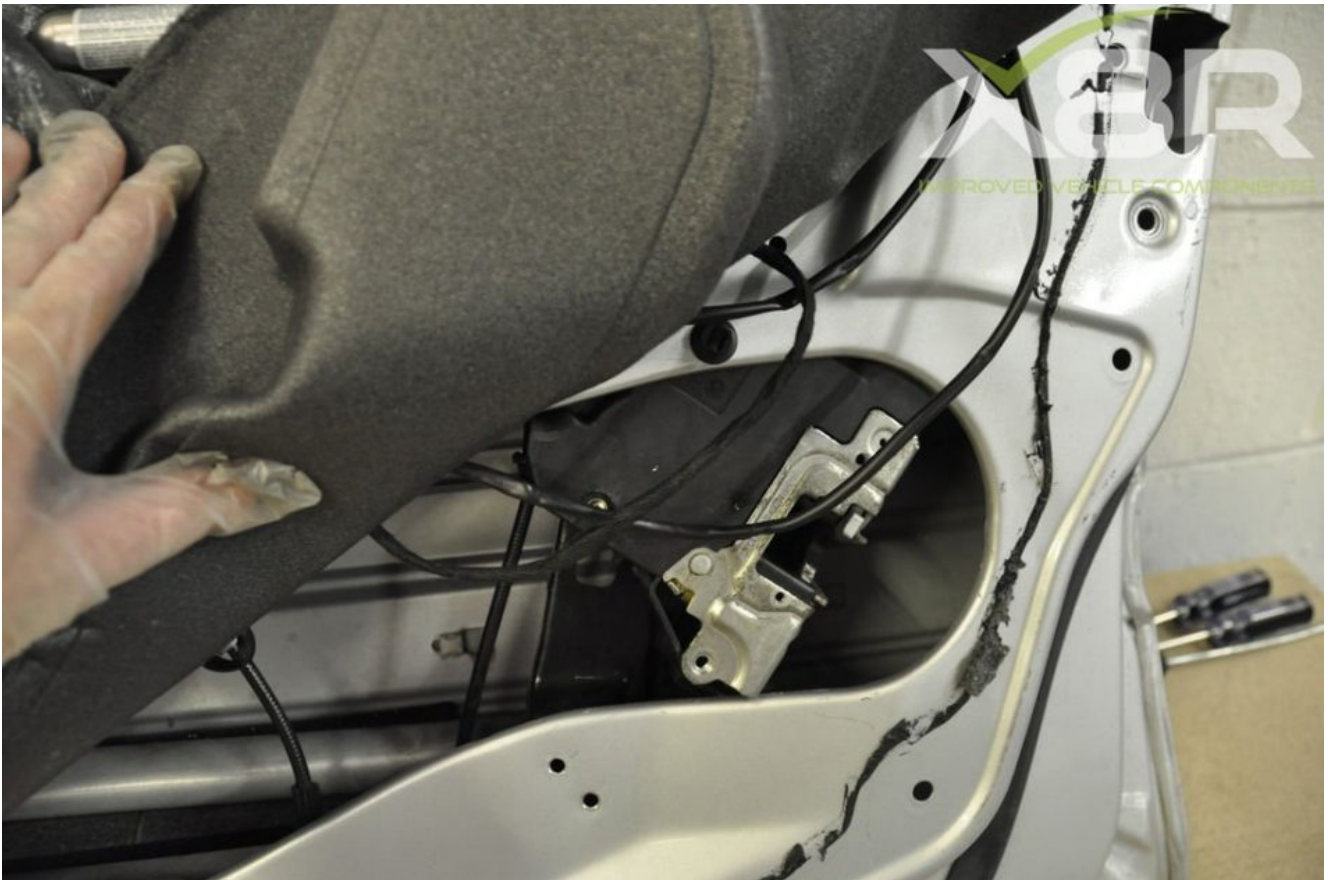
## Step 5: Remove actuator

Slide actuator out of position and remove.

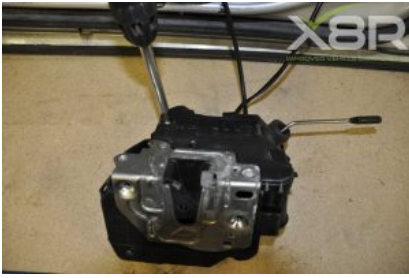
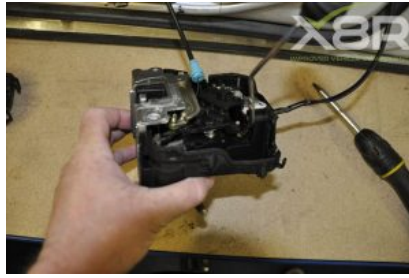
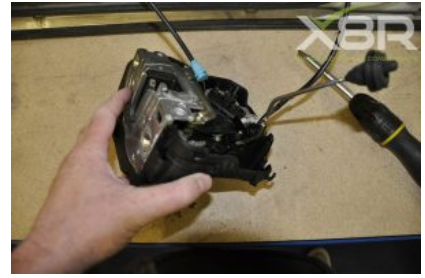
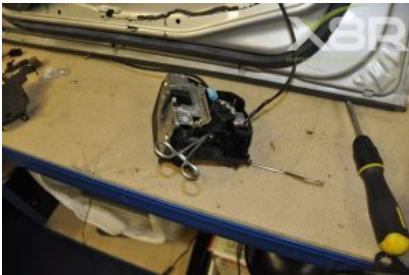
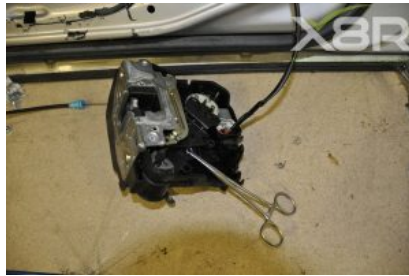
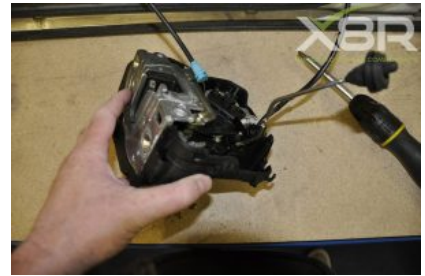
## Step 6: Replace spring

Lever off actuator cover.

Replace spring as shown, remove any remains of old spring if in place. If there are remains of the spring deep in the top recess please remove.

Using the pliers insert the top leg of the spring in to the top recess, if you are unable to do this it is likely that there is still remains of the old spring in place. Attach pliers firmly to the bottom leg of the spring and force in to bottom recess, some force will be required, do not worry the spring will not snap.

Once in place slide bottom leg of spring in to the smallest part of the recess. Test function to make sure spring is seated correctly; test again when reattaching actuator to vehicle.
