# Mercedes C E CLK W203 W211 W209 Class Door Lock Actuator Spring Repair Instructions Rear Door

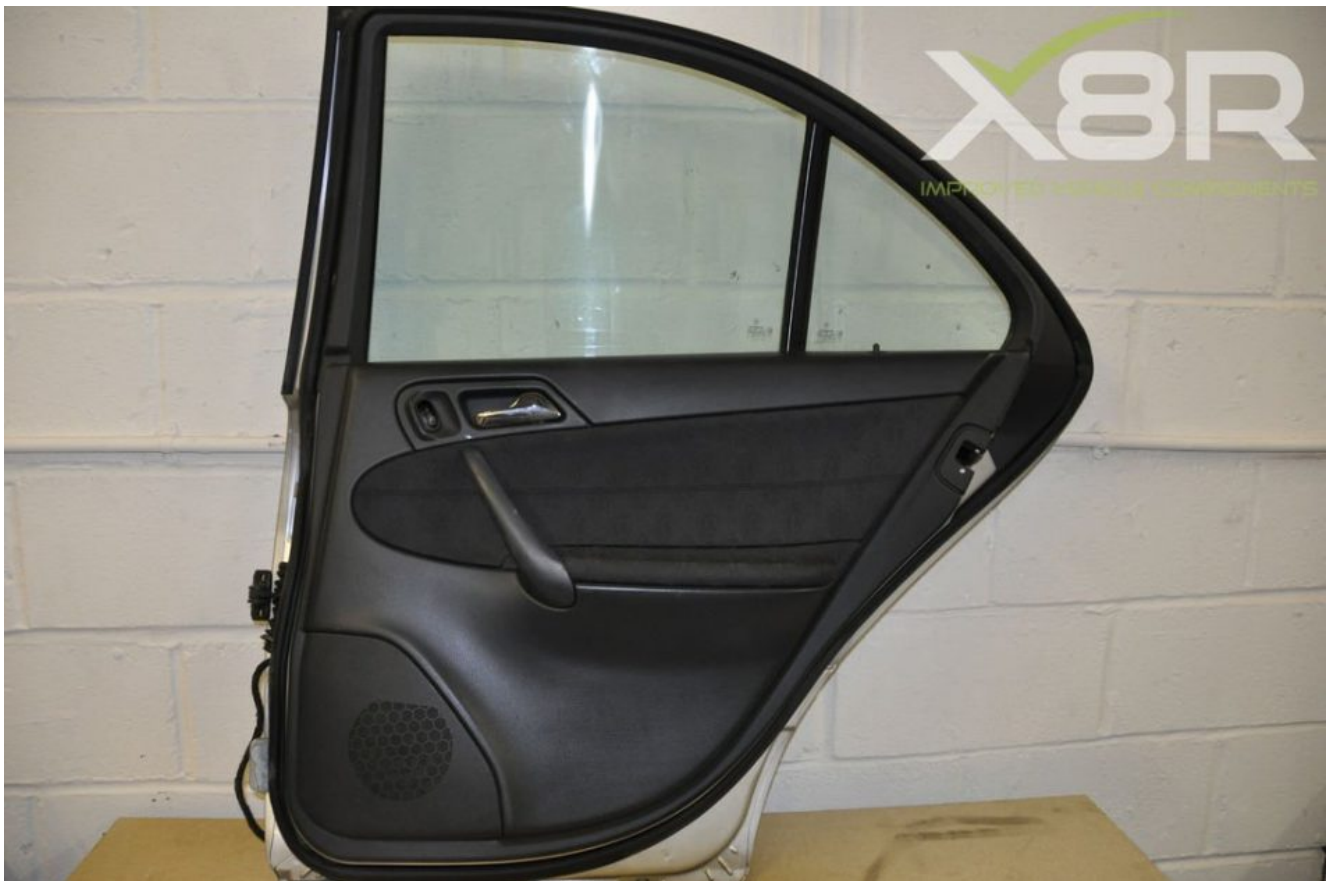
Door lock bouncing up and down? Finding it increasingly difficult to lock your Mercedes?

The Springs within the door lock actuator mechanisms deteriorate over time, the OEM spring is made from cheap metal which wears quickly, this wear leads to the symptoms noted above.

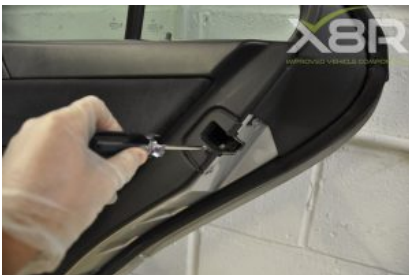
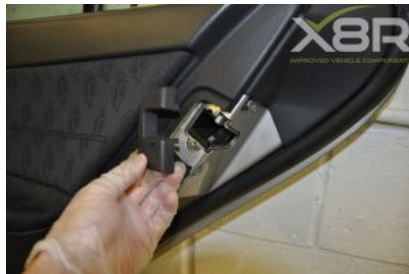
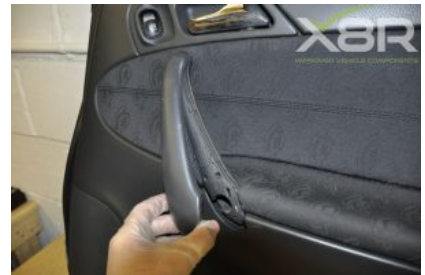
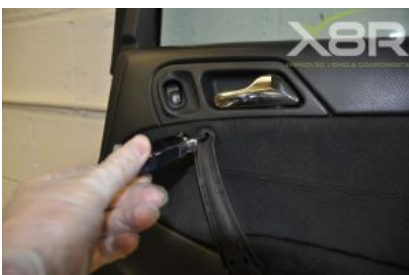
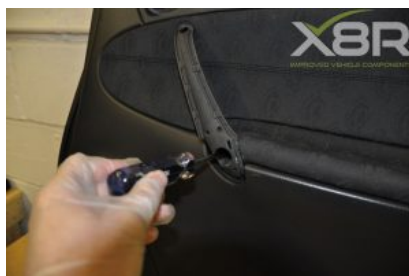
## Step 1: Remove door trim

Remove T20 torx and remove lock cover.

Lever off the cover from the door handle.

Remove the two torx bolts under the handle cover (T25, T30)

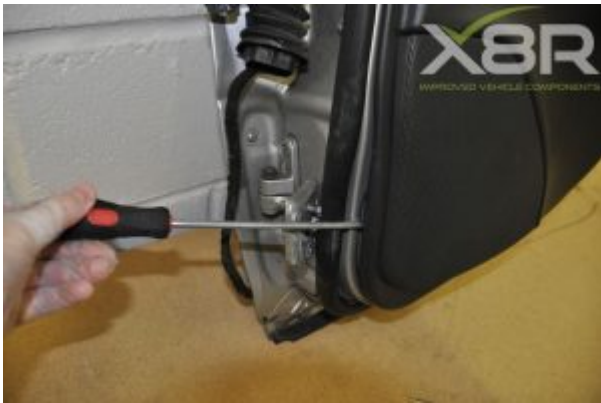
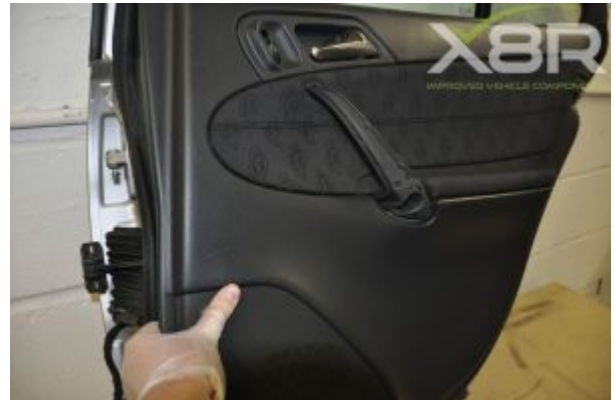
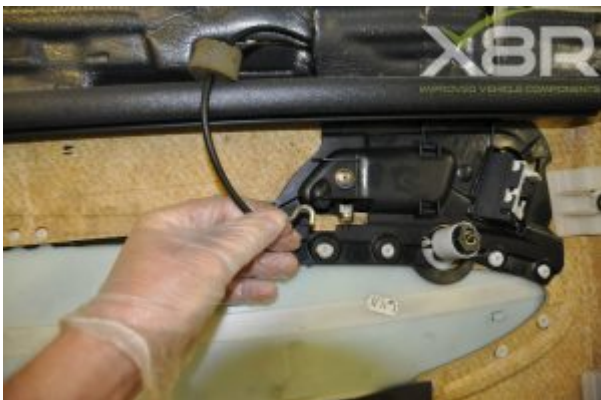
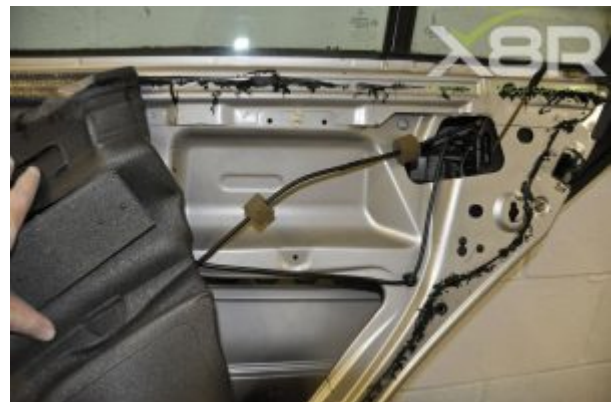
## Step 2: Remove door trim - 2

Lever around the edge of the door trim and lift off.

Pull upwards and forwards on the door trim to remove.

Disconnect hook linkage.

Remove insulation to access actuator.

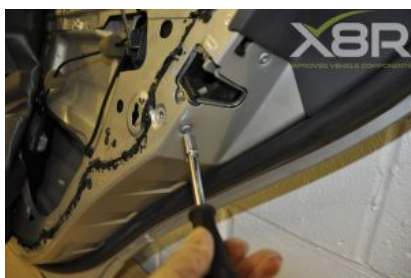
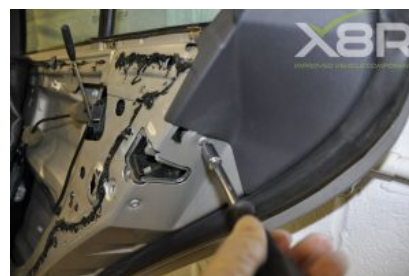
## Step 3: Release actuator

Remove the 3x T30 Torx screws holding the actuator.

If present remove plastic cover.

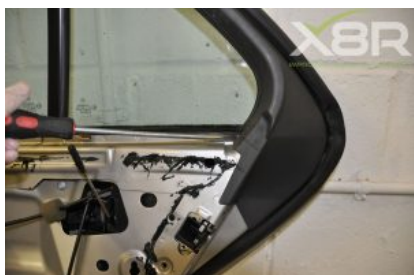
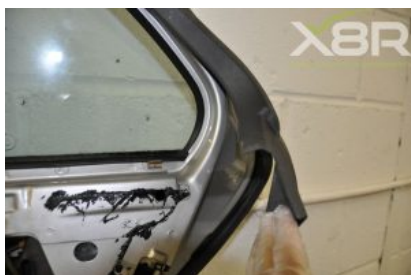
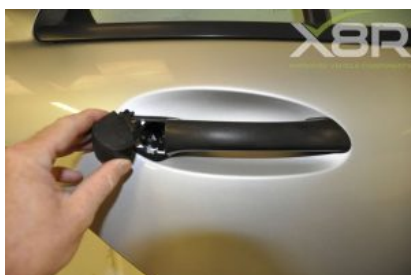
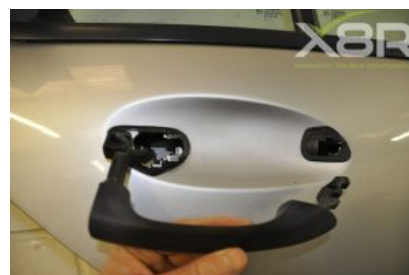
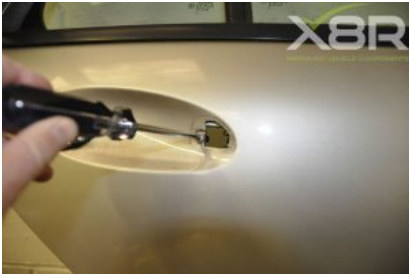
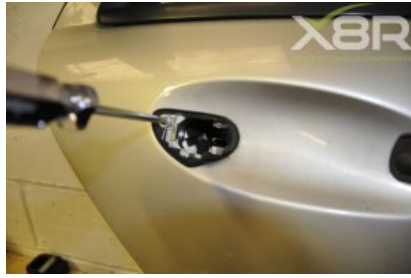
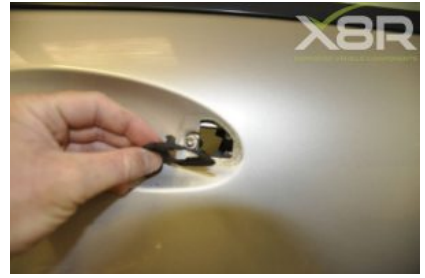
## Step 4: Remove outer handle

Pry off plastic cover.

Remove blanking plate and unscrew T20 torx holding outer door handle.

Remove handle, firstly remove small part of handle released by removing the previous T20 Torx then slide handle in to recess left from this to release from vehicle.

Remove the two exposed T20 torx screws which will release the bearing clamp.

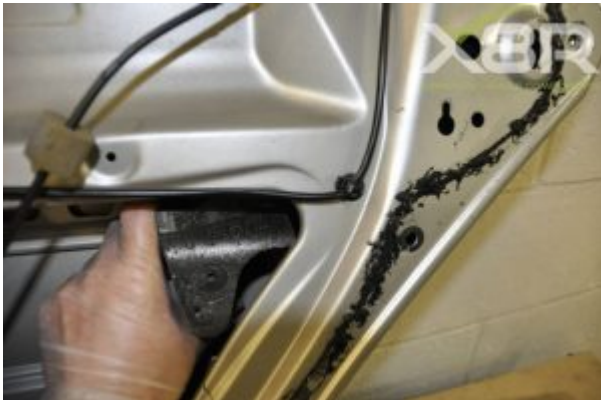
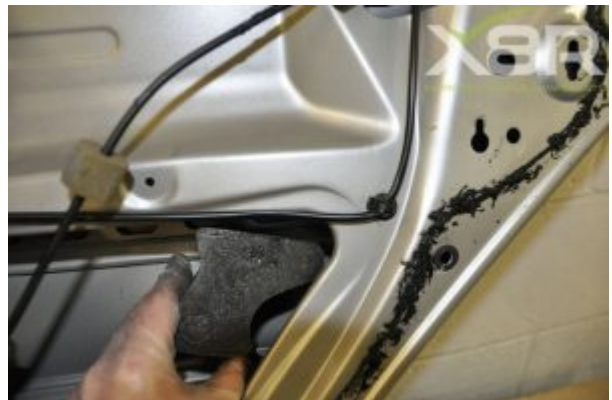
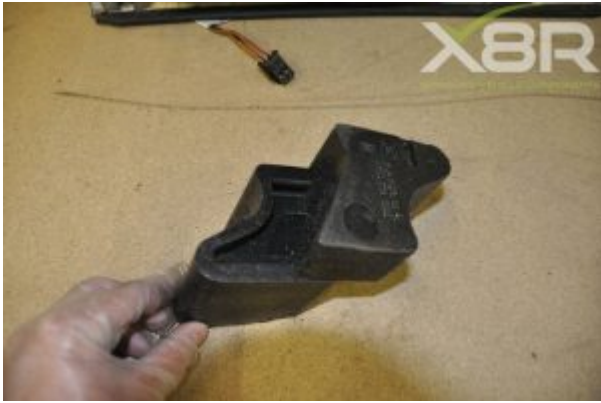
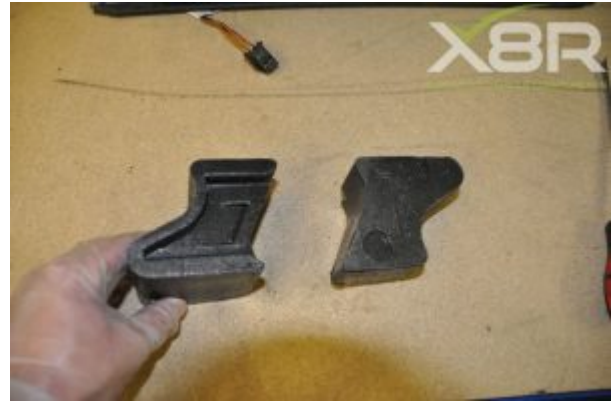
## Step 5: Remove foam block

Remove foam block, this sits in front of actuator preventing removal.

This consist of two blocks as shown these slide together, slide the two blocks apart and remove.

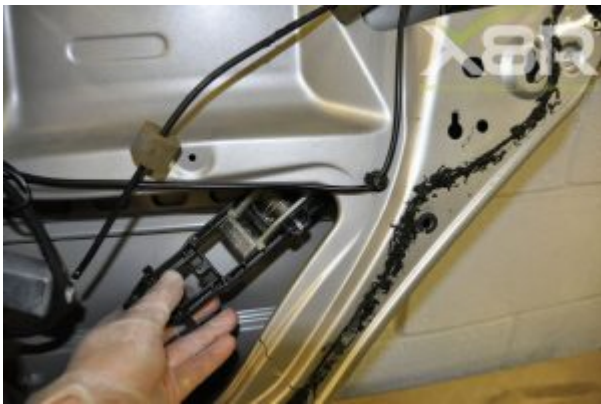
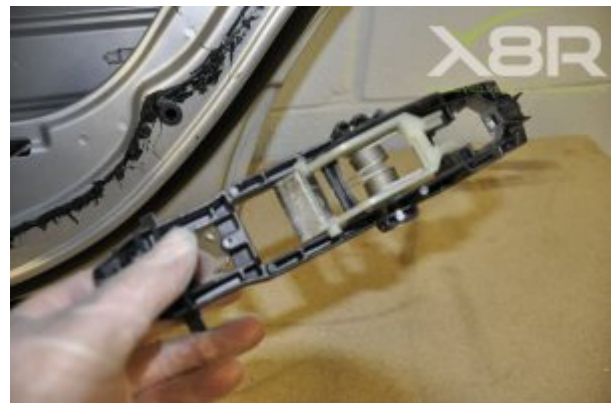
## Step 6: Remove bearing clamp

Remove bearing clamp.

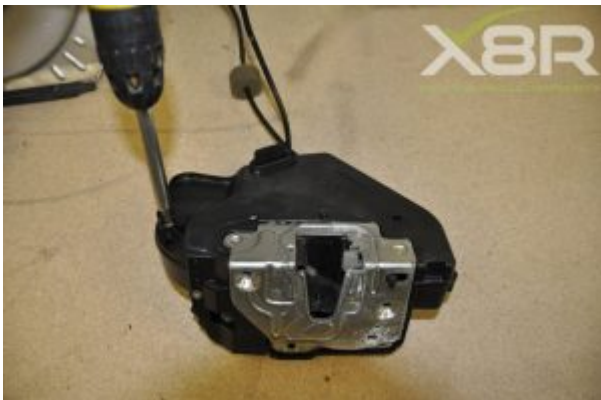
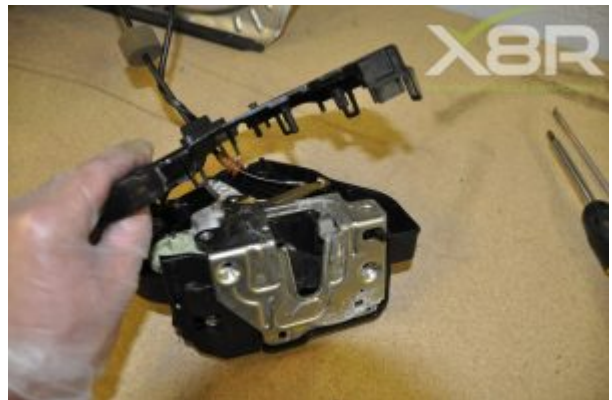
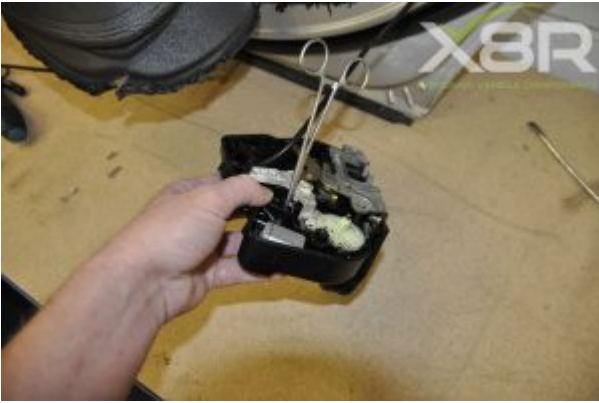
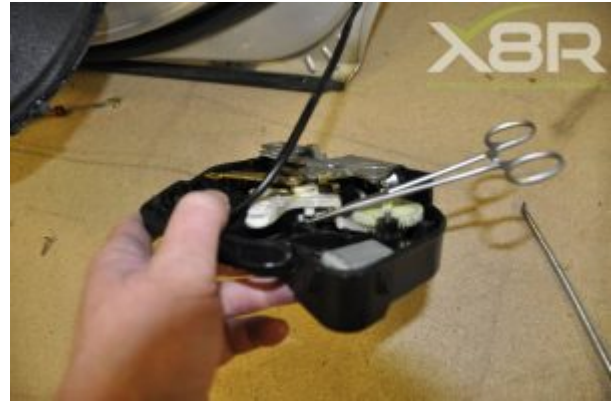
## Step 8: Fit replacement spring

Lever off actuator cover.

Replace spring as shown, remove any remains of old spring if in place.

If there are remains of the spring deep in the top white recess it will be hard to remove, you will need to drill this out from directly above using a 1mm drill piece.

Using the pliers insert the top leg of the spring in to the top white recess, if you are unable to do this it is likely that there is still remains of the old spring in place, if so please drill these out as noted above.

Attach pliers firmly to the bottom leg of the spring and force in to bottom recess, some force will be required, do not worry the spring will not snap.

Once in place slide bottom leg of spring in to the smallest part of the recess. Test function to make sure spring is seated correctly; test again when reattaching actuator to vehicle.
