Windscreen Wiper Linkage Clip Repair Fitting Instructions

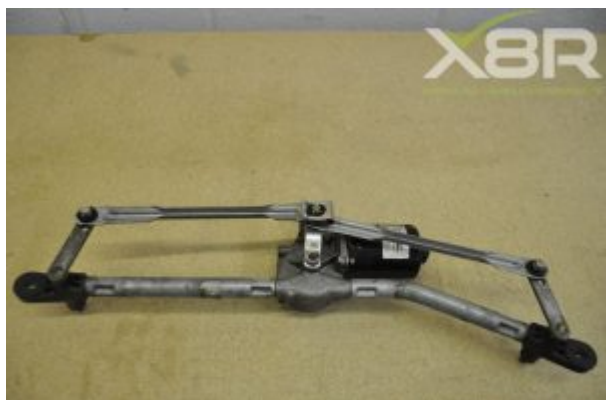
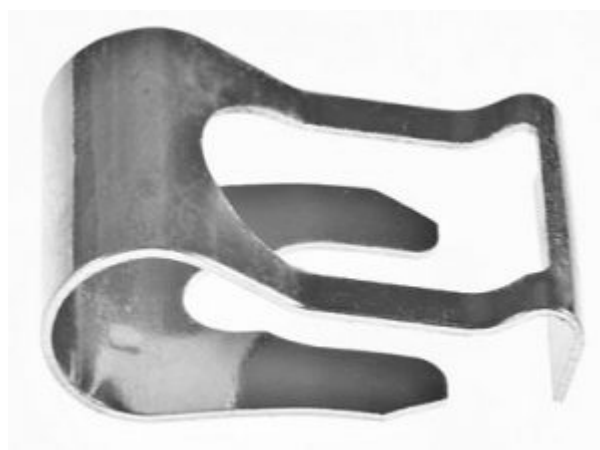
The poor quality plastic rod ends on your vehicles wiper linkages wear causing these symptoms. The poor quality plastic rod ends wear quickly and the wiper push rods pop off of their respective ball joint causing the symptoms noted above.

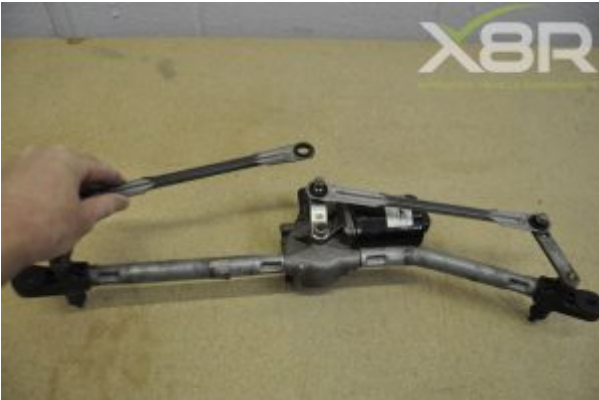
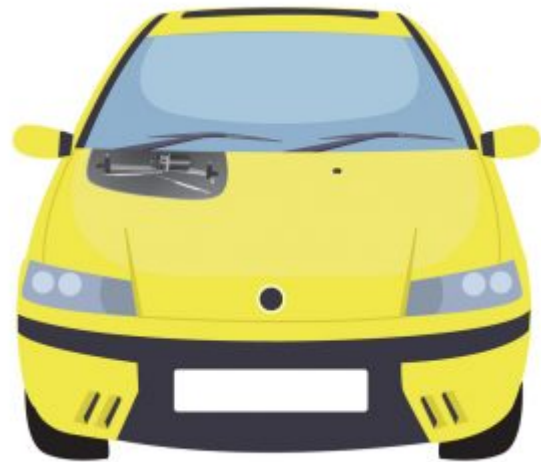
Step 1: Step 1- Locate Worn Linkage

Firstly you will need to locate your wiper mechanism and identify which ball joint is causing the issue (on occasions multiple joints can fail). The image shows the location of the wiper linkage mechanism on the Fiat Punto, the linkage will be found here or close by on all vehicles.

On the mechanism you will likely find a linkage arm hanging off a ball joint as illustrated. Alternatively pull on each ball link to determine which is at fault, the worn link will pop off easily.

You will need to remove the scuttle panel to access the mechanism, on most vehicles you will be able to repair in situ, if not possible or you are struggling to install please remove mechanism and install clip on work bench, this makes the job much easier.

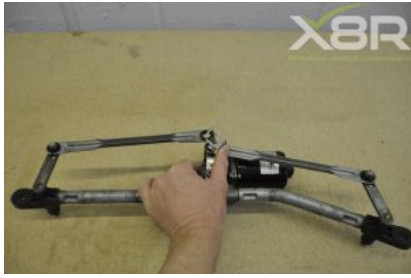
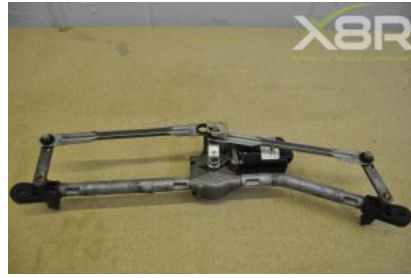
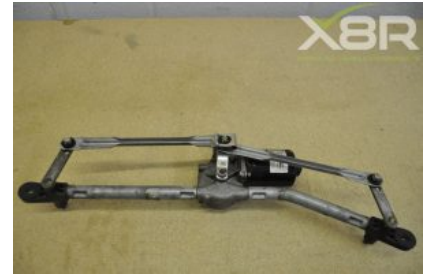
Step 2: Step 2- Fit Repair Clip

Lift off loose wiper linkage and slide our clip on to the ball joint as shown.

Holding the rear of the clip so it stays flush on the base of the ball joint, take the linkage arm and put under the front of the clip as illustrated. Maintaining the location of the rear of the clip lift the linkage arm up and push on to the ball joint, this will require some force (remember the tighter the fit the better, preventing the linkage lifting off in future) do not worry the clip will not break under force. Once on the ball joint the clip will release and hold the joint firm. Rotate the clip to the best position to hold the joint. To make the joint extra secure a cable tie can be looped around the clips arms then around the wiper rod.

The clip should hold the joint in place, test by pulling on the joint. If the fit needs to be tighter or looser use pliers to adjust the clip. Operate wipers and check clip doesn't catch on any other components.
