CITROËN C4 Glove Box Compartment Lid Handle and Spring Replacement Repair Fix Kit Black Reinforced Plastic Instructions Install Guide

by x8rltd

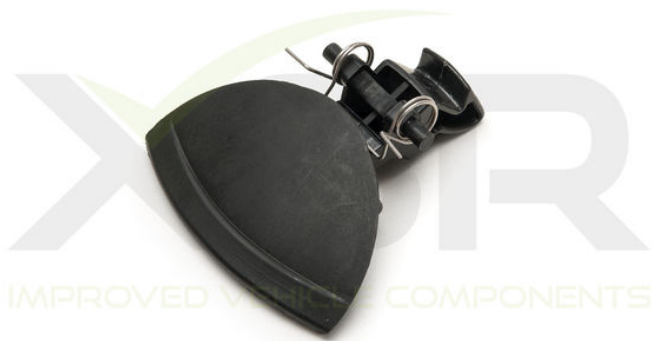
We now have THE solution, our reinforced plastic replacement glove box handle, this fits in the slots that the old handle used to and operates in exactly the same way, the only change is that it is made from a reinforced plastic and will not break. Our part simply push fits in to place and takes just seconds to install. Also included is a replacement spring in case the original has been lost or damaged. Save the cost of a complete new glove box lid which would just fail again, install our unique reinforced plastic handle and resolve this fault permanently.

1x Plastic handle

1x Handle spring

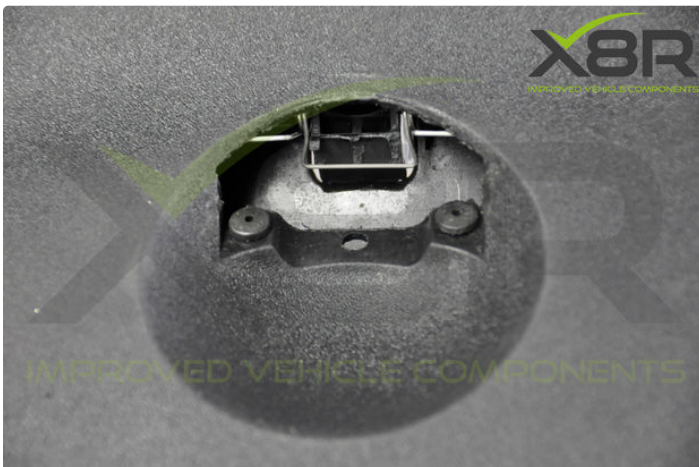
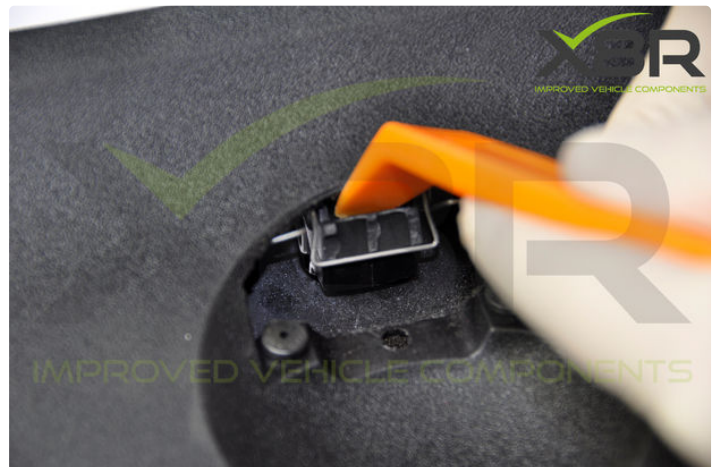
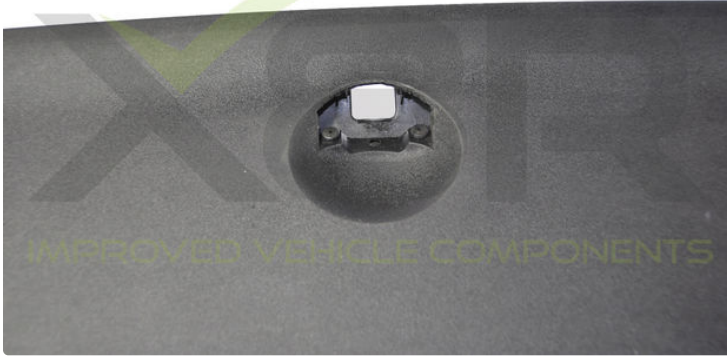
Step 1: Remove the Broken Handle

The glove box handle is delicate and snaps easily stopping normal usage of the glove box.

It is a common issue with Citroen C4 vehicles for items to become jammed in the glove box lid, this leads to pressure being put on the lid handle, this is a delicate item and snaps very easily. Until now this either left owners without access to their glove box or the glove box was left permanently open. The only alternative was to purchase a new lid at £150+

- Using a blunt pry tool - so as not to damage the glove box, pry out the old handle from within the glove box.
